Technical Service  
Bulletin

| Subject:<br><br>CHECK ENGINE LIGHT ON WITH DTC P0524 OR P055F | Bulletin No.: 01-003/24 |

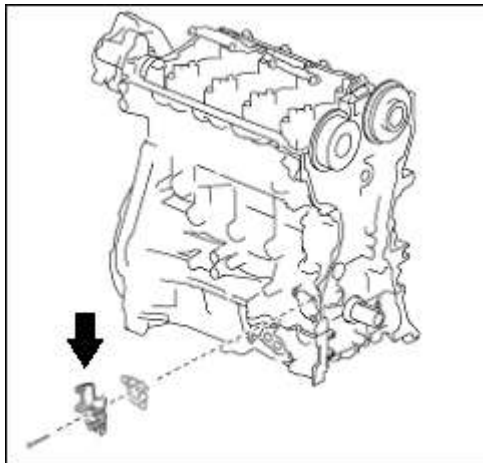
Some vehicles may have the check engine light on with DTC P0524:00 or P055F:00 stored in memory. Contamination in the engine oil may cause the engine oil solenoid valve to become stuck, resulting in improper operation of the oil pump

and improper oil pressure.

- DTC P0524:00 (Engine oil pressure too low)
- DTC P055F:00 (Engine oil pressure malfunction)

The control software of the PCM has been modified to eliminate this concern. In addition, the production process has been modified to reduce contamination in the engine oil solenoid valve, oil pump, spacer and oil filter.
