**Diagnostic Sheet**

# Ghibli QP Levante DTC P0090

This Diagnostic Sheet serves as a guide and provides additional diagnostic info for possible DTC "P0090 - Fuel Pressure Regulator Control Circuit 1 Open" stored in the engine control unit (ECM).

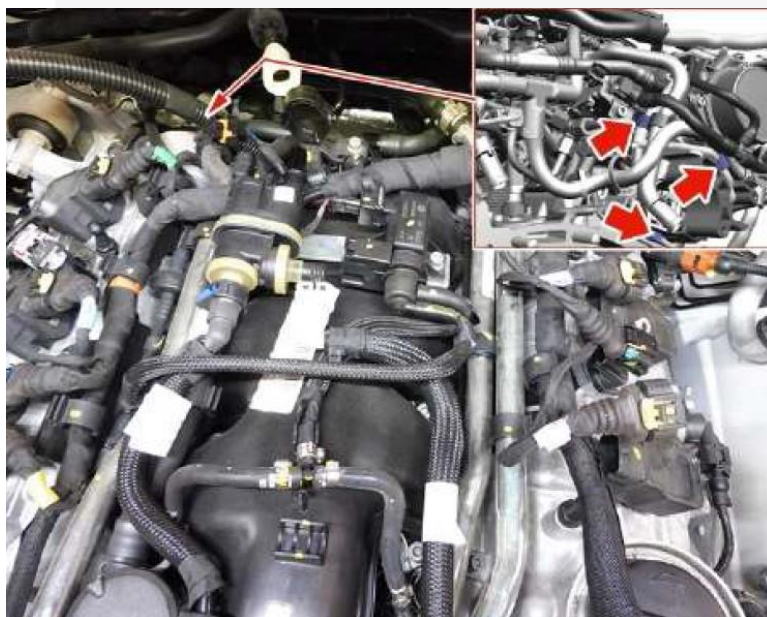
3. the procedure indicated in the workshop manual up to **step 22** (where you release the clips shown in the photo):

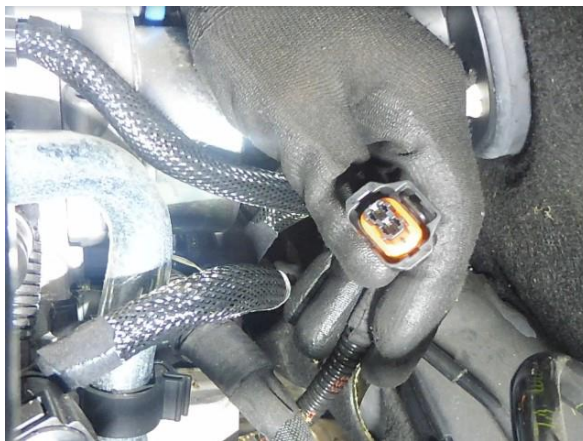
4. Identify the connector to allow correct procedure.

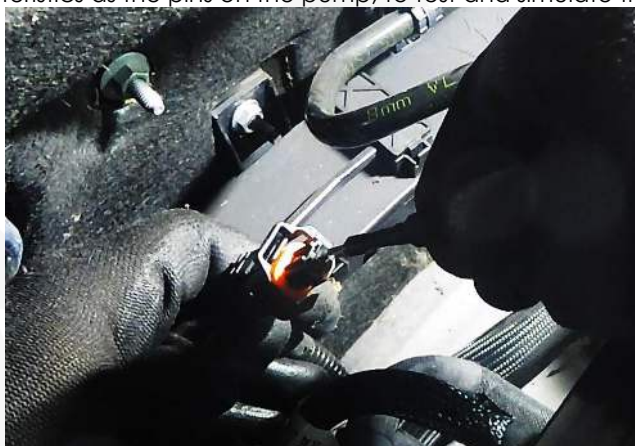
5. Insert the feeler (p/n 900100002) in one of the two seats of the connector. The feeler is designed to have the same dimensional characteristics as the pins on the pump, to test and simulate the coupling.

6. Wiggle test the connector manually, with the sensor inserted, to check that there is no looseness of the seat such as to allow the sensor itself to come out, partial or total (this is to simulate the vibrations of the vehicle during operating conditions).

10. If, on the other hand, the test is *negative*, i.e. the probe does not remain well connected even to only one of the two seats, the component is **NOT OK**. At this point the **connector** (p/n 673015820) needs to be **replaced**.

11. Replace the connector following the procedure indicated in the bulletin **MAS000766**.
