In the instrument cluster, the symbol for "12 V battery" and the message "Switch on vehicle" sporadically appears

| Topic number | LI54.10-P-076820 |
| Function group | 54.10 - Battery, power supply, voltage converter |
| Validity | MODEL 206 up to production 12/15/23<br>MODEL 254 up to production 12/15/23 |

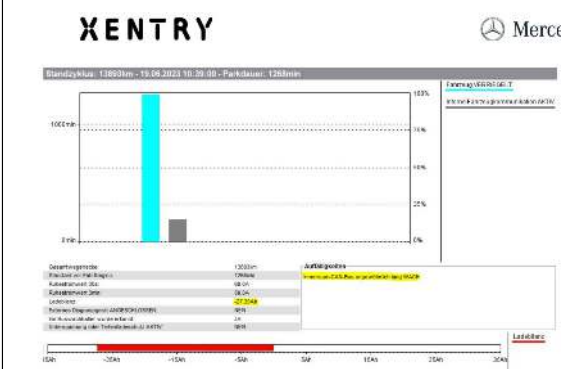
In the subsequent analysis of the 12 V on-board electrical system data, the following parameters are noteworthy (see picture 1 in the attachment):

- Charge balance negative when stationary.
- Interior CAN bus is awake for an unusually long time while the vehicle was locked.
- 12 V battery SOC (state of charge) during subsequent engine start is 45% or less.

The door control unit (N69/x) may sporadically keep the interior CAN bus awake.

Update the software on all 4 door control units (N69/1, N69/2, N69/3 and N69/4).

For this, a commissioning of the door control units must be carried out on all 4 doors (N69/1, N69/2, N69/3 and N69/4).
