## Technical product information

| <b>Topic</b> | Coolant pump leaking (part number 07P 121 008C) - Low coolant warning - Engine overheating - DTC's evident |
| <b>Brand</b> | Bentley |

### W12 Bentayga - New Continental GT/GTC - New Flying Spur

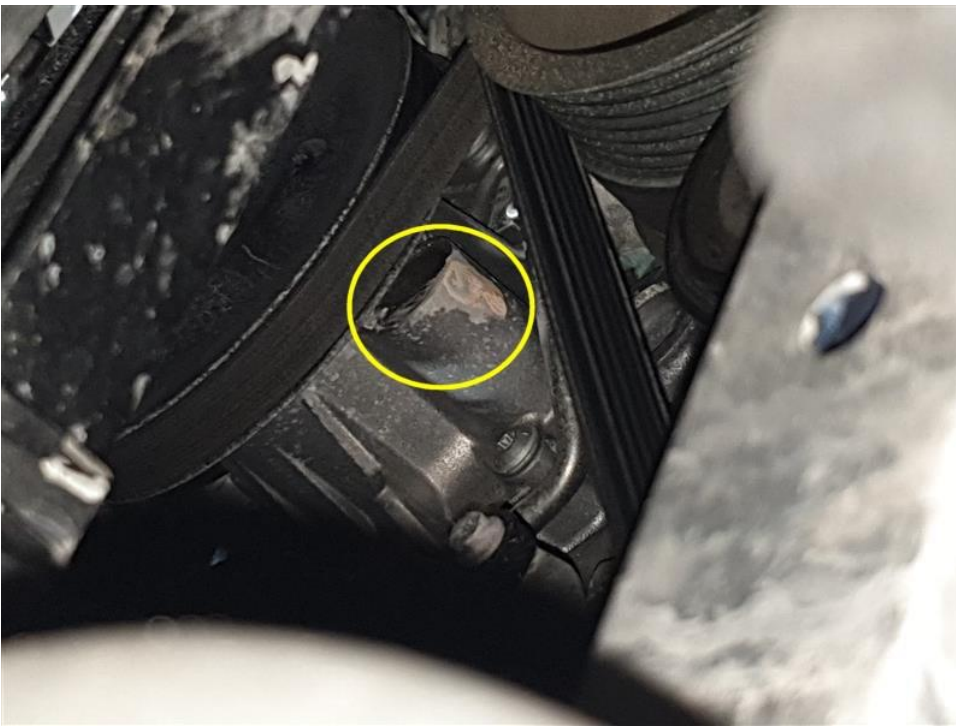
Figure 1

- Refer to the video located within the Bentley Hub reference TPI 2071238/- the video shows an example of a coolant pump with no leak although a small coolant witness mark is evident (Figure 1) in this scenario the coolant witness mark should be cleaned off (using a suitable cleaning agent) to the condition shown in Figure 2

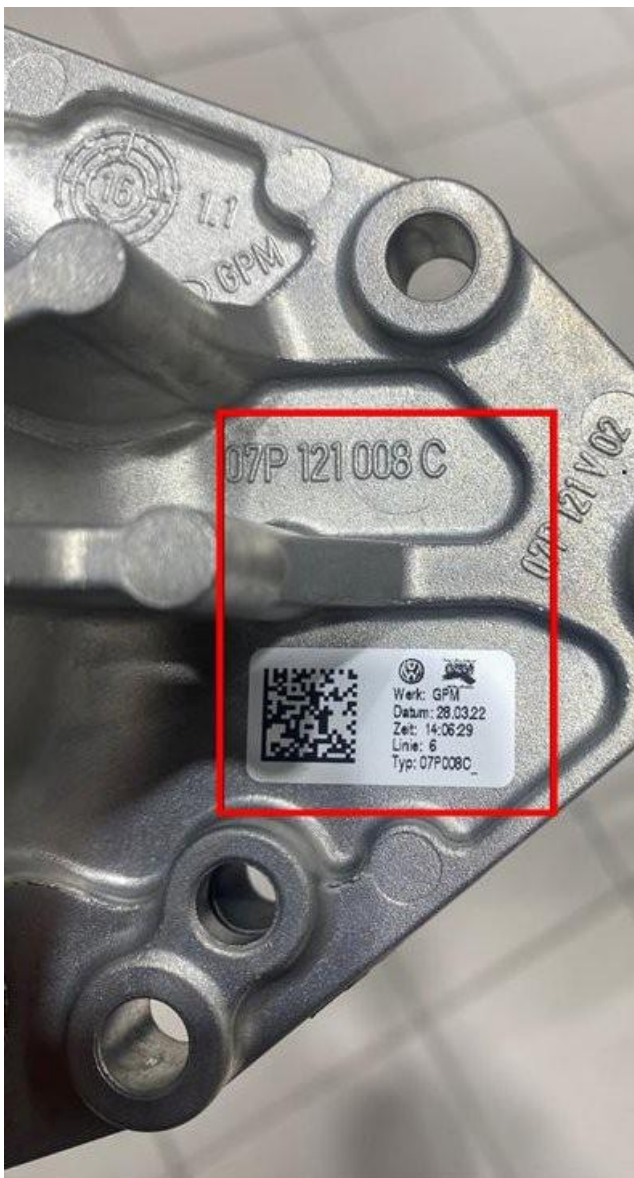
- Clear photo of the coolant level
- Clear photo of the original mechanical coolant pump part number **07P 121 008C** (Figure 4)
- Video of the coolant leak whilst carrying out the pressure test
- Current ODIS log
- Await feedback via DISS before replacing any parts

*NOTE: The photo shown in Figure 4 is a C level coolant pump (shown removed from the vehicle for photographic purposes) a borescope may have to be used for photographs of the coolant pump when fitted*

6) Once permission has been given via the technical DISS query, replace the following

- Mechanical coolant pump - Rep.Gr 19
- Solenoid for coolant circuit N492 assembly - Rep.Gr 19
