## STAR ONLINE PUBLICATION

**Case Number:** S2208000063 Rev. A

**Symptom/Vehicle Issue:** Loss Of Power Steering Assist. U0131 Lost Communication With Electro Hydraulic Power Steering Control Module (EHPS).

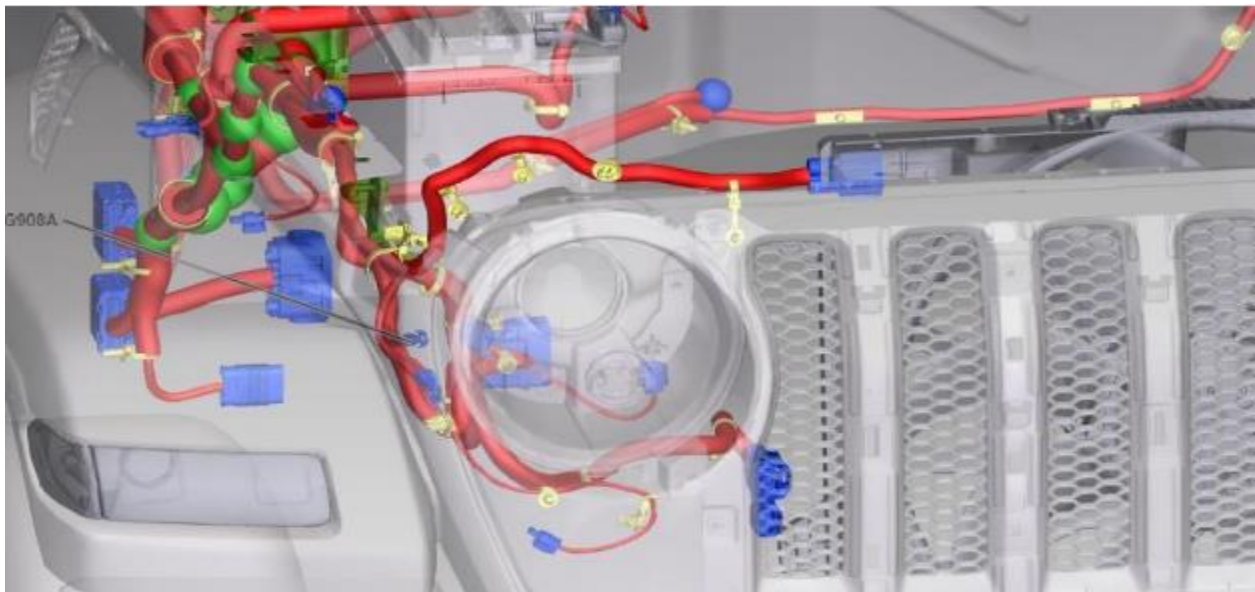
**Discussion:** The customer may experience a lack of power steering assist. Diagnostic trouble code (DTC) U0131 - Lost Communication With Electric Power Steering Control Module may be present. This may be caused by the ground wire not being fully welded/secured to the ground eyelet.

Fig 1. G908A location.

**Diagnosis:** Inspect the G908A ground located behind the passenger side headlight. Determine if the ground eyelet is properly secured to the ground wire. Check if the eyelet from the power steering ground is bent. If it is, carefully bend it back straight (Fig. 2).

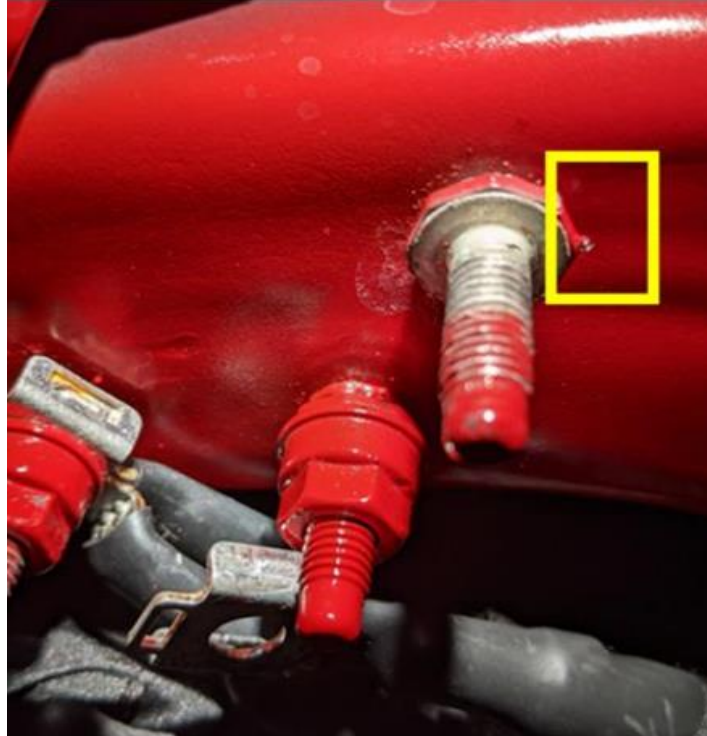
Fig 3. Weld slag to be filed or ground down.

Using a wire brush, file and emery cloth as needed, clean the top weld stud thoroughly from any impurities that can cause the eyelet not to make flat contact (dirt, paint, glue, weld slag). Refer to Fig 3. Reconnect the ground wire and torque to 15 N-m (11 Ft-Lbs.).

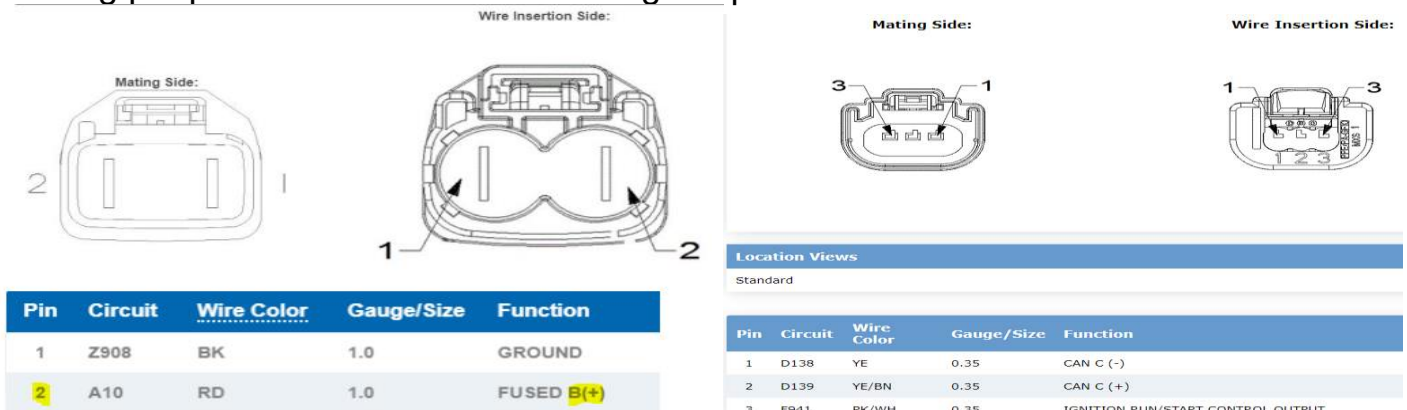
Using a multimeter verify power and ground at the EHPS C1 connector. C2 connector has pins for CAN communication and Ignition Run Start. Inspect each for problems including pin pushout and harness routing. Repair as needed.

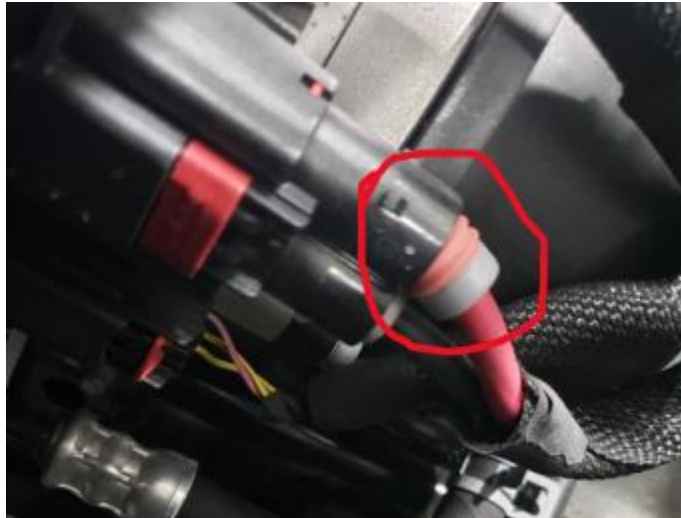
Example Of Pin Push Out.

After repair, clear the diagnostic trouble codes (DTCs). Test drive to confirm U0131 is resolved.
