# Technical Service Bulletin

## 69 Airbag warning light on, DTCs B100A1B, B100B1B

69 24 09 2072349/2 May 7, 2024. Supersedes Technical Service Bulletin Group 69 number 23-05 dated December 13, 2023 for reasons listed below.

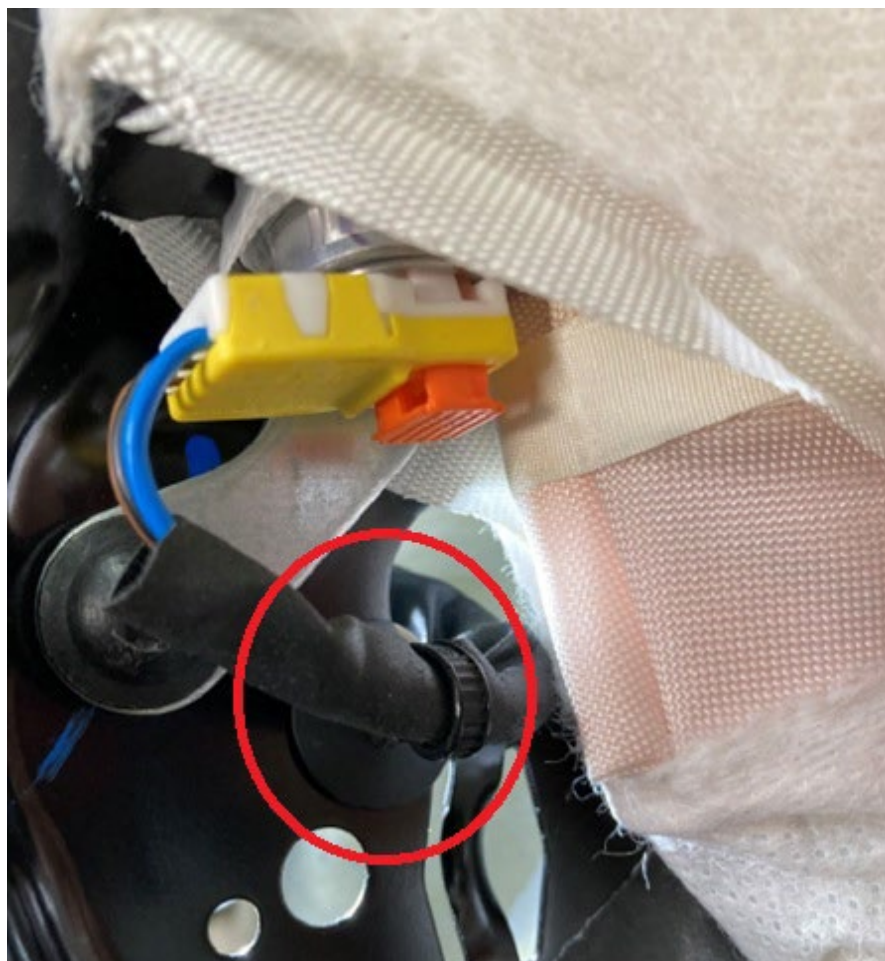
**Tip:** The clip in the photo is not identical with the clip to be used.

**Figure 1.** Install additional zip tie/clip when installing new thorax airbag wire harness.

1. Replace the affected side/thorax airbag wire harness(es) according to: *Elsa>>Repair manual>>Body>>Body Interior>>Passenger Protection, Airbags, Seat Belts>>Thorax Airbags>>Thorax Airbag Wire, Removing and Installing.*
2. Route the new thorax airbag wire harness(es) as close to the seat frame as possible. To do so, use zip tie/clip **N10546701** (Figures 1, 2).

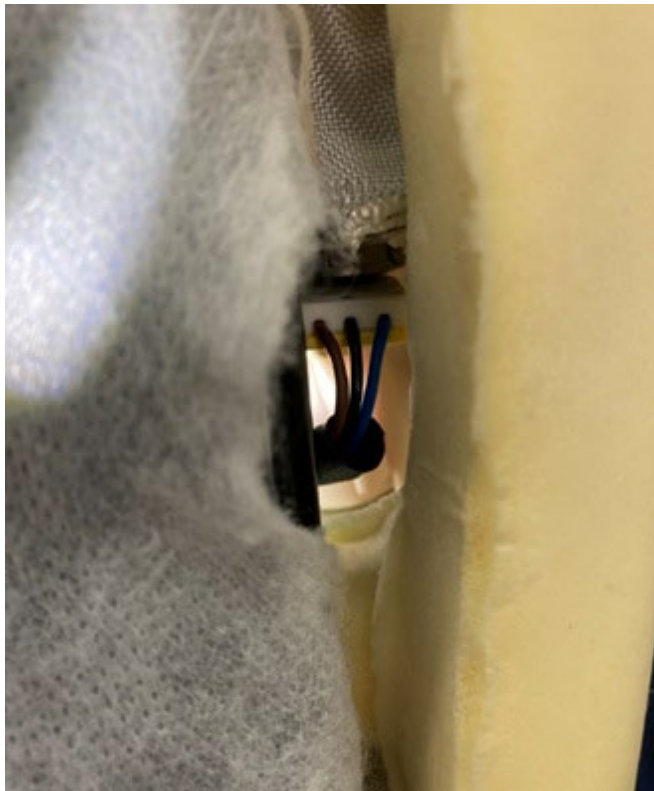
**Figure 2.** Route new thorax airbag wire harness as close to seat frame as possible.
