# Technical Service Bulletin

## 93 "Electrical system: Malfunction! Safely turn off vehicle" is in the cluster, DTC P0AC000 is stored in battery module

93 24 56 2059309/6 May 16, 2024. Supersedes Technical Service Bulletin Group 93 number 23-18 dated August 10, 2023 for reasons listed below.

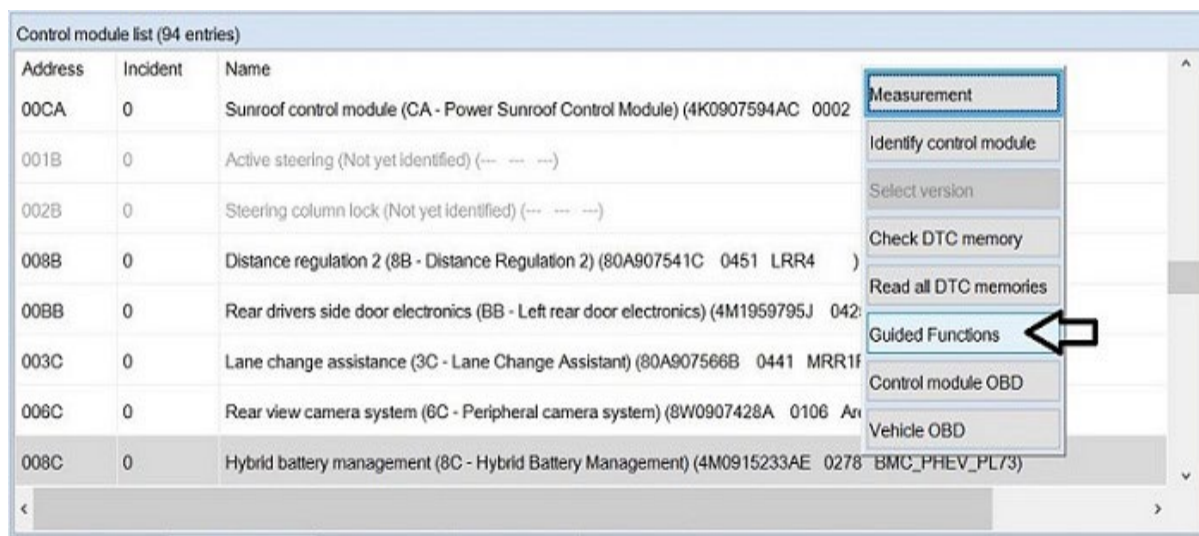
**Figure 2. Guided Functions.**

- 1 To obtain the data we need to use the diagnostic scan tool then right-click and select the hybrid battery management module, J840 (address word 008C), and select “Guided Functions” (Figure 2).

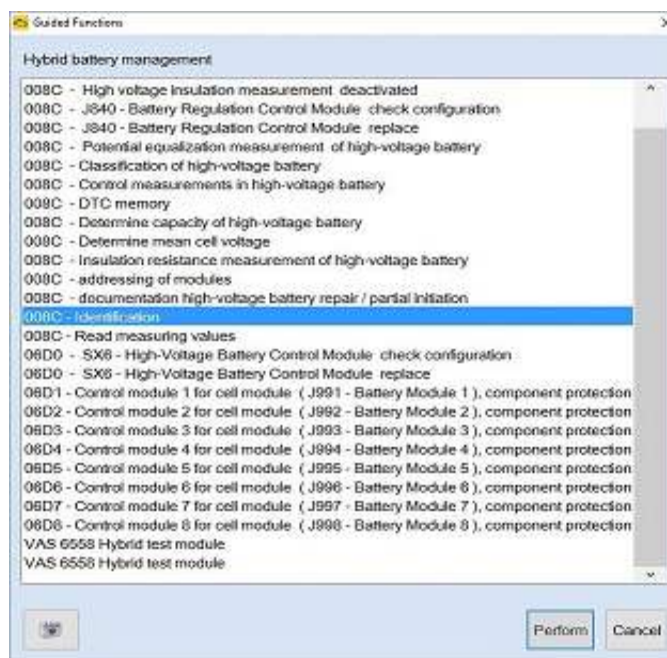
**Figure 3. Guided Functions Menu.**

- 2 In the Guided Functions menu select 008C – Identification and click “Perform” (Figure 3).
