**Technical Service Bulletin (TSB)**  
**Diesel Exhaust Fluid (DEF) Fluid Freezing**

| REFERENCE: | TSB: 14-005-24<br>GROUP: 18 - Vehicle Performance | Date: | June 28, 2024 | REVISION: | 14-003-23 |
| CAUSE: | DEF fluid freezing | | | | |

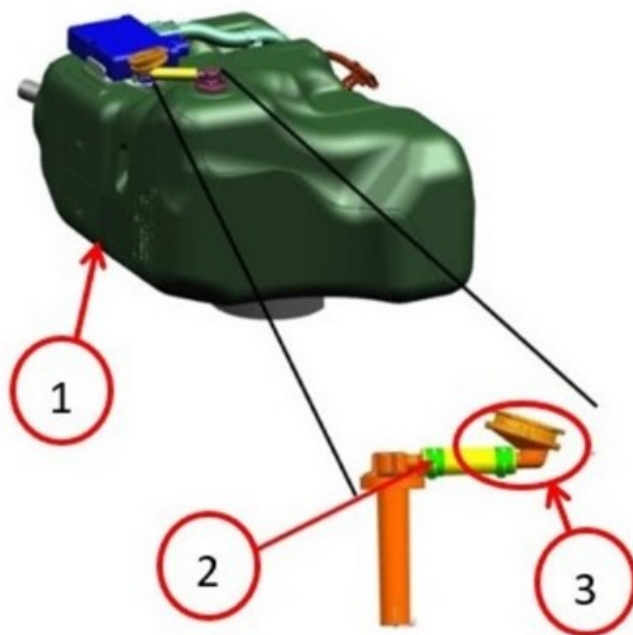
**Fig. 1**  
DEF Tank Assembly

1 - DEF Tank  
2 - Hose Clamp  
3 - GVV

1. \*\*Loosen the hose clamp on the Grade Vent Valve (GVV) hose and replace the GVV from the DEF tank  
Fig. 1.
