## Cayenne E-Hybrid – Thermal Management Fault P26B100 Causes Check Engine Light

### Vehicles Affected

### Condition

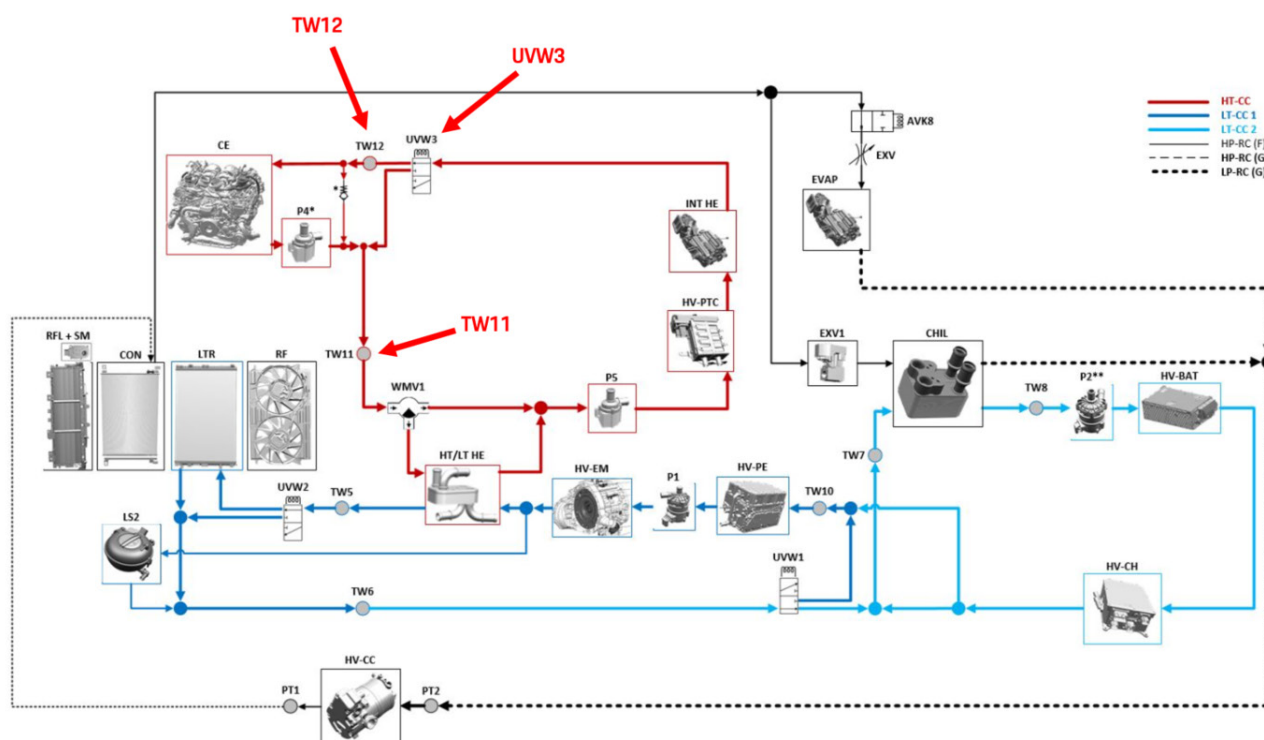
Figure 1 - Cayenne E-Hybrid Cooling Circuits

The aforementioned fault code may be caused by a misdiagnosis of the directional control value for the high temperature circuit for interior heating (valve UVW3).

Under certain operating conditions, a lack of temperature difference between the engine coolant circuit and the interior heating circuit may result in the TME diagnosing valve UVW3 as "stuck closed", despite no mechanical fault in the valve.

Valve UVW3 controls the direction of coolant flow based on engine temperature. The valve defaults to closed, such that the high-temp circuit excludes the engine coolant circuit. During this "small-circuit" operation, the HV PTC controls the temperature of the high-temp circuit to meet the heating and air conditioning demands of the customer. Once the engine reaches 40° C, the valve opens ("large-circuit" operation) and the high-temp circuit uses the engine heat instead of the HV PTC.

The status of UVW3 is diagnosed by the absolute value of the temperature difference between TW11 and TW12. The TME expects this difference to be **larger than 7° C while the valve is closed, but smaller than 7° C while the valve is open**. Certain operating conditions may cause the temperature difference to fall below 7° C while the valve is closed. If this condition exists while the TME is performing diagnostics, the valve will be diagnosed as open, although it is closed due to the engine temperature being less than 40° C.

1. Please create a VAL to document the occurrence of the fault.
2. If applicable, please complete Workshop Campaign WPRO. Please complete this Campaign per the instructions in TI 177/23, before performing any other diagnosis work for the subject fault code.  
**NOTE:** Please reference the below table for the appropriate TME software and coding information after completing Campaign WPRO. (Data Record Version can be found in the Extended Identifications tab for the TME.)

3. If the fault persists after performing WPRO, please continue with other means of diagnosis.
