# Technical Service Bulletin

## 96 Lane change assist: side assist and exit warning system: unavailable. Sensor view restricted (DTC C12AA00)

96 24 99 2073683/2 June 21, 2024. Supersedes Technical Service Bulletin Group 91 number 24-01 dated April 16, 2024 for reasons listed below.

| Model(s) | Year | VIN Range | Vehicle-Specific Equipment |
|---|---|---|---|
| RS 6 Avant | 2021 - 2025 | All | Not Applicable |

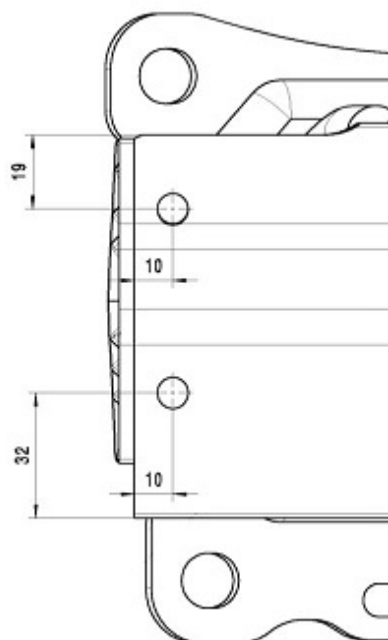
**Figure 1:** Illustration showing positioning of holes for spreader rivets.

To secure the covers, two holes (8 mm diameter) must be drilled on each side (left and right) of the bumper cover, as shown in the image below:

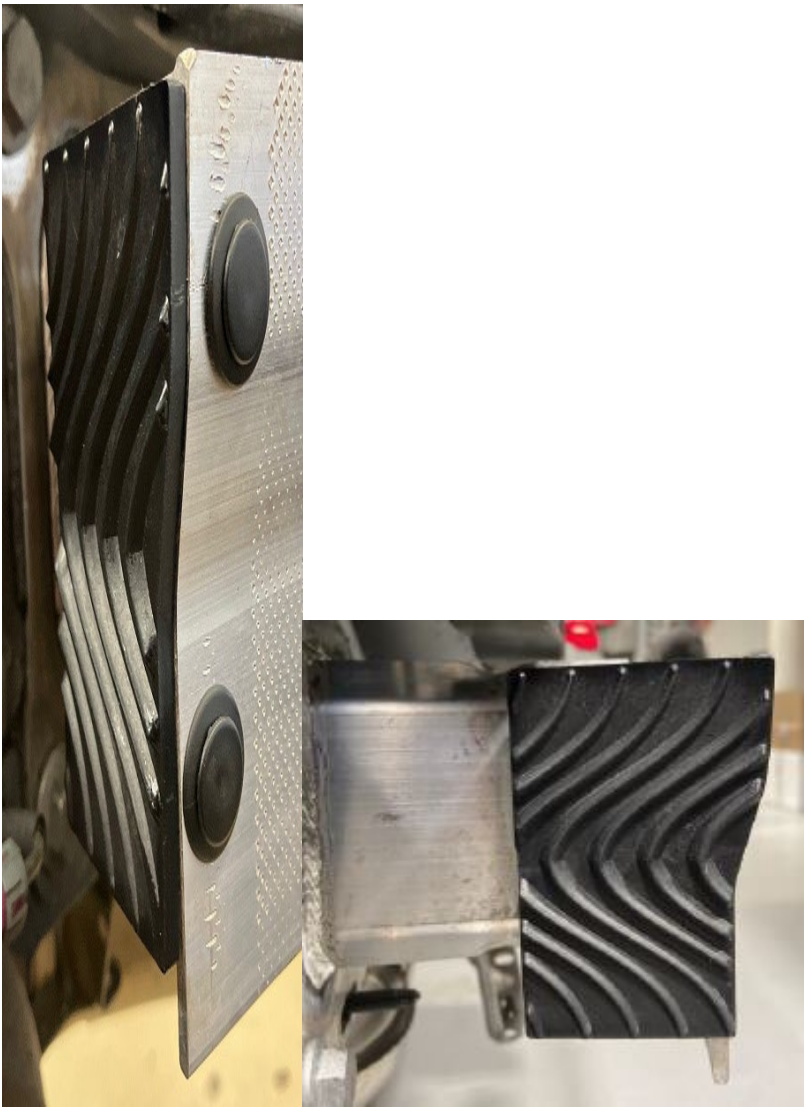
**Figure 2:** Cover mounted on bumper carrier (left side).

Re Cover the holes and openings on both sides of the bumper carrier. To do so, please use the following covers:

Please use the following spreader rivet to secure the covers on the bumper carrier:
