# Technical Service Bulletin

## 93 PSS Q8 e-tron: Charging flap module without search illumination; P33E300; B1A8AF3

93 24 61 2073481/3 June 28, 2024. Supersedes Technical Service Bulletin Group 93 number 24-58 dated May 31, 2024 for reasons listed below.

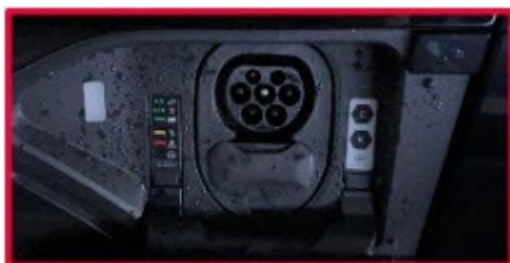
If the vehicle is only equipped with single charging flap module the orientation light does not work. An error in the OBC (00C6) software means that the orientation light LED is not activated when the vehicle is equipped with only one charging flap module.

*Figure 2: Vehicle with a non-functioning orientation light in the charging flap module.*

- Explain to the customer that a solution is expected to be available by the end of the 3<sup>rd</sup> quarter of 2024 (subject to change) and that no repairs are necessary at this point. Do not replace any components for this condition since this will not resolve the customer's concern.
- Create a PSS record in the PSS application through the Pending Service Solutions (PSS) link in AccessAudi (under *Related Links >> Service*).
