## Technical product information

| <b>Topic</b> | DTC P0B2500 logged within address 0021 (Battery Energy Control Module 2) - Dynamic ride system warning visible |
| <b>Transaction No.</b> | 2068946/7 |

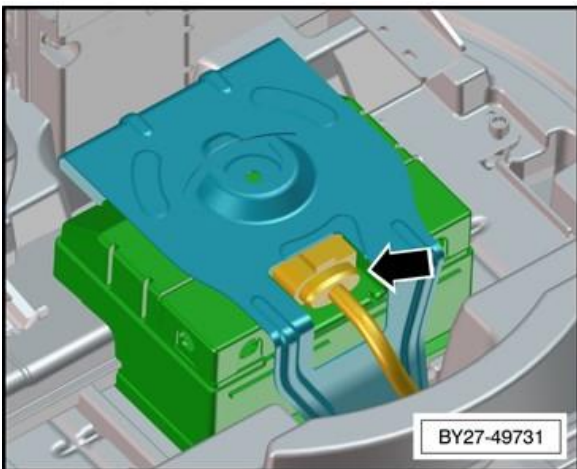
3) Referring to Figure 2 - Check the security of the harness connector

- In the event the harness connector is not secure the operative must secure the connector

Should an issue be identified with the connector or super capacitor which doesn't allow the connector to be secured the operative must feedback via DISS
