| <b>Subject:</b><br><br><b>IN-VEHICLE NETWORK MALFUNCTION WARNING MESSAGE<br/>AND DTC B119F:01</b> | <b>Service Alert No.: SA-038/24</b> |
| | <b>Last Issued : 06/13/2024</b> |

2019-2023 Mazda3  
2020-2023 CX-30  
2021-2023 CX-5  
2023 CX-50  
2021-2023 CX-9  
2022 MX-30

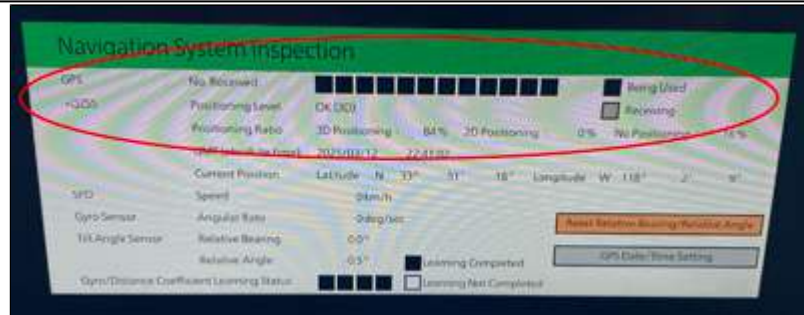
Good Signal

**Does the vehicle receive a Good GPS signal? (Example of a good GPS signal below)**

- **Yes:** Replace the TCU. See [SA-025/23](#)
- **No:** Go to next step.
