# TECHNICAL SERVICE BULLETIN

| DA20-032C | ITB20-025C | May 14, 2024 |

## DTC B2724-23 AND/OR C1B56-04 STORED, AND/OR RAB ERROR MESSAGE OR WARNING

APPLIED VEHICLES: 2020-2021 QX50 (J55)  
APPLIED DATES: Built on or before October 08, 2021  
APPLIED SYSTEM: Rear Automatic Braking

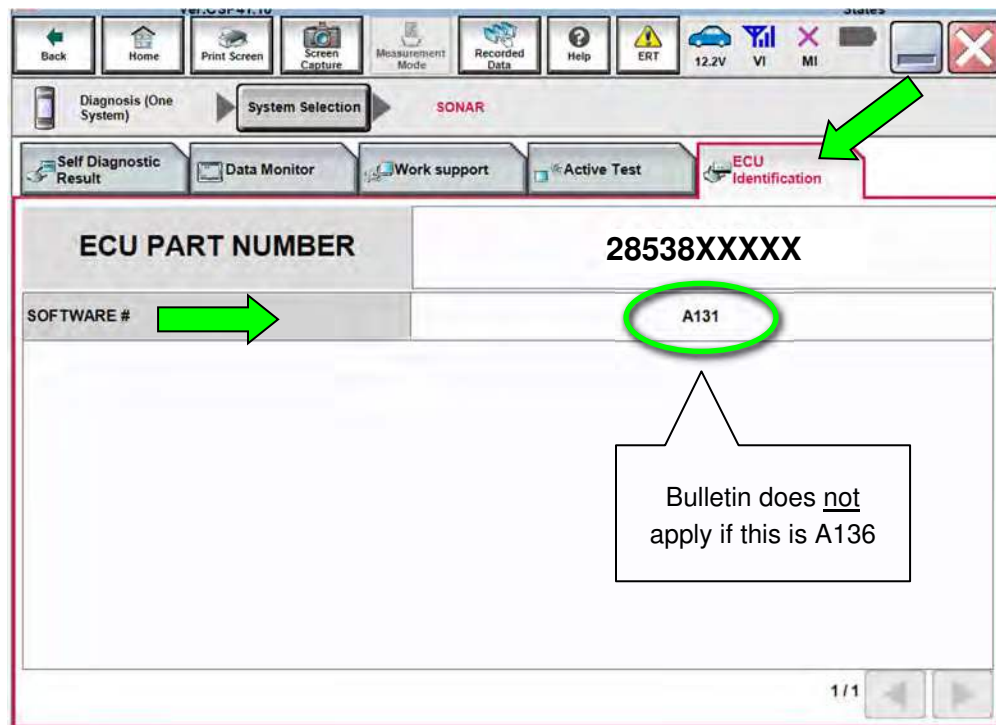
Figure 5

- If the SOFTWARE # is A136, this bulletin does not apply. See the Electronic Service Manual (ESM) for further diagnostic information.
- If the SOFTWARE # is not A136, proceed to step 17.

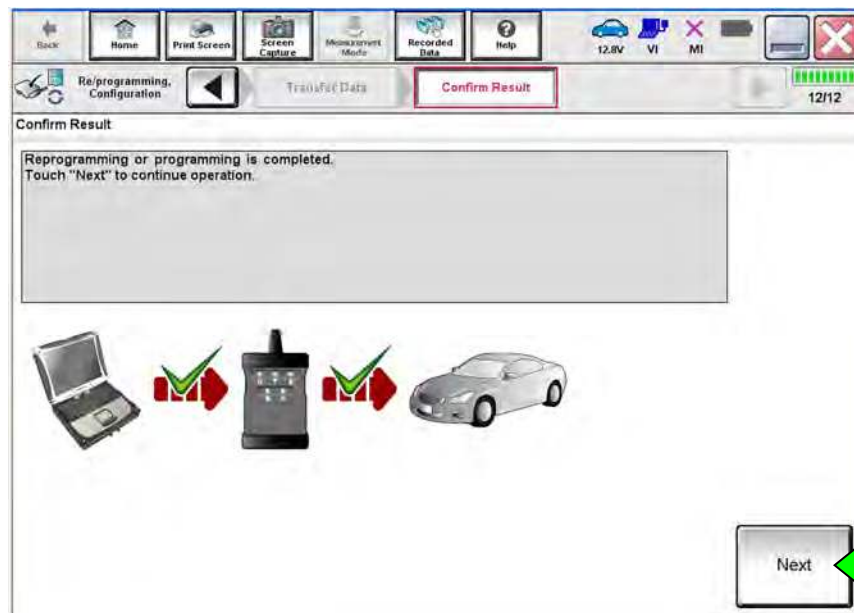
- When the screen in Figure 21 displays, the reprogramming is complete.
  - If the screen in Figure 21 does not display (indicating that reprogramming did not complete), refer to Sonar Control Unit Recovery on the next page.
37. Disconnect the battery maintainer or smart charger from the vehicle.
38. Select Next.

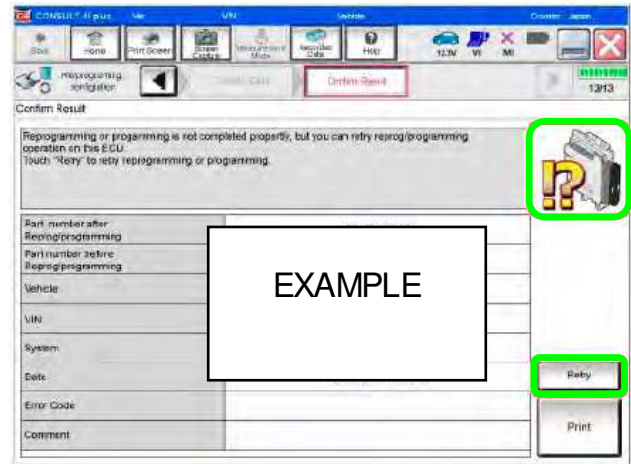
Figure 22

If reprogramming does not complete and the “!?” icon displays as shown in Figure 22:

- Check battery voltage (12.0 - 13.5 V).
- Ignition is ON, engine OFF.
- External Bluetooth® devices are OFF.
- All electrical loads are OFF.
- Select retry and follow the on screen instructions.
- “Retry” may not go through on first attempt and can be selected more than once.

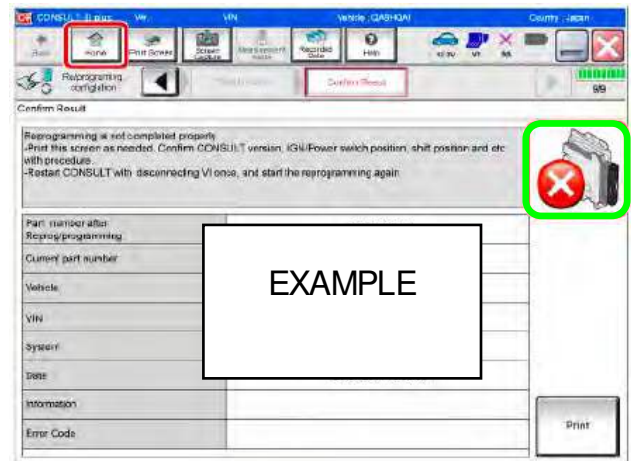
Figure 23

If reprogramming does not complete and the “X” icon displays as shown in Figure 23:

- Check battery voltage (12.0 - 13.5 V).
- CONSULT A/C adapter is plugged in.
- Ignition is ON, engine OFF.
- Transmission is in Park.
- All C-III plus / VI cables are securely connected.
- All C-III plus updates are installed.
- Select Home, and restart the reprogram procedure from the beginning.

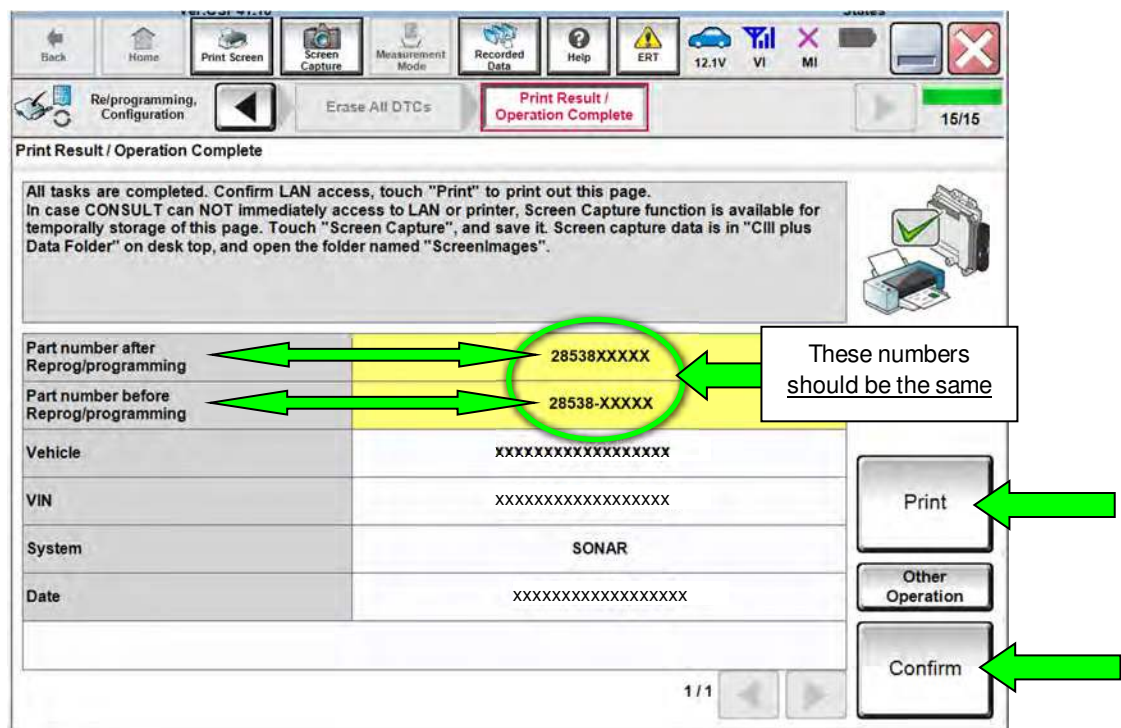
HINT: When the entire reprogramming process is complete, the screen in Figure 25 will display.

HINT: For this reprogram, the before and after reprogramming part numbers should be the same. This is not an error.

41. Print a copy of the screen below (Figure 25) and attach it to the repair order for warranty documentation.

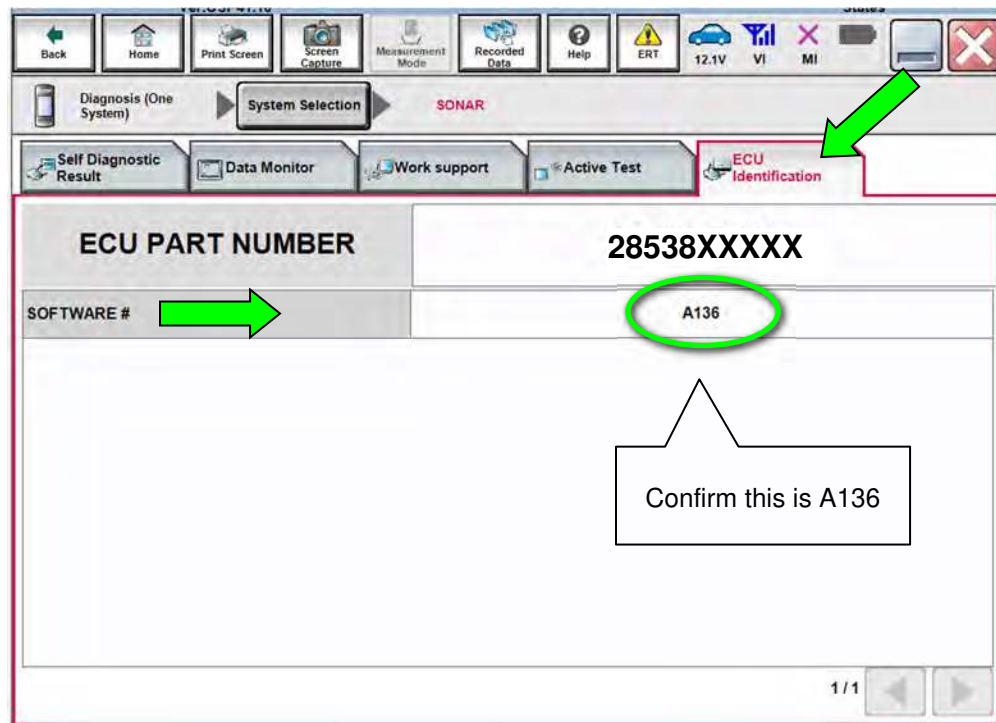
Figure 36

- If the SOFTWARE # is A136, proceed to step 62.
- If the SOFTWARE # is not A136, reprogramming did not successfully complete. Go back to step 18 on page 6 and perform the procedure again.

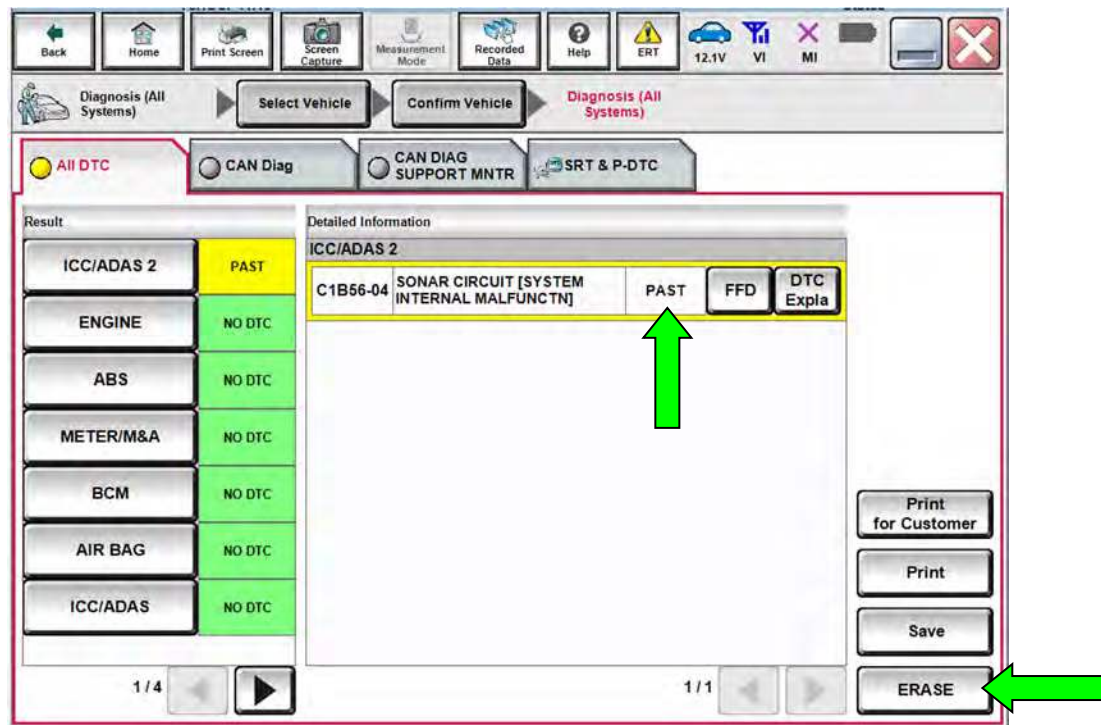
Figure 39

64. Select Automatic Selection(VIN).
65. Select Confirm.
66. Select Confirm.
67. Turn the ignition OFF, then turn the ignition ON.
68. Confirm DTC C1B56-04 is displayed as PAST (not CRNT). See Figure 39.
69. Select ERASE.
