# TECHNICAL SERVICE BULLETIN

| DA22-001C | NTB22-038C | May 14, 2024 |

## RAB WARNING LIGHT ON IN INSTRUMENT PANEL AND/OR DTC B2724-23 STORED

**APPLIED VEHICLES:** 2019-2022 Altima (L34)  
2019-2021 Kicks (P15)  
2019-2023 Murano (Z52)  
2019-2021 Rogue Sport (J11)  
2019-2021 Versa (N18)

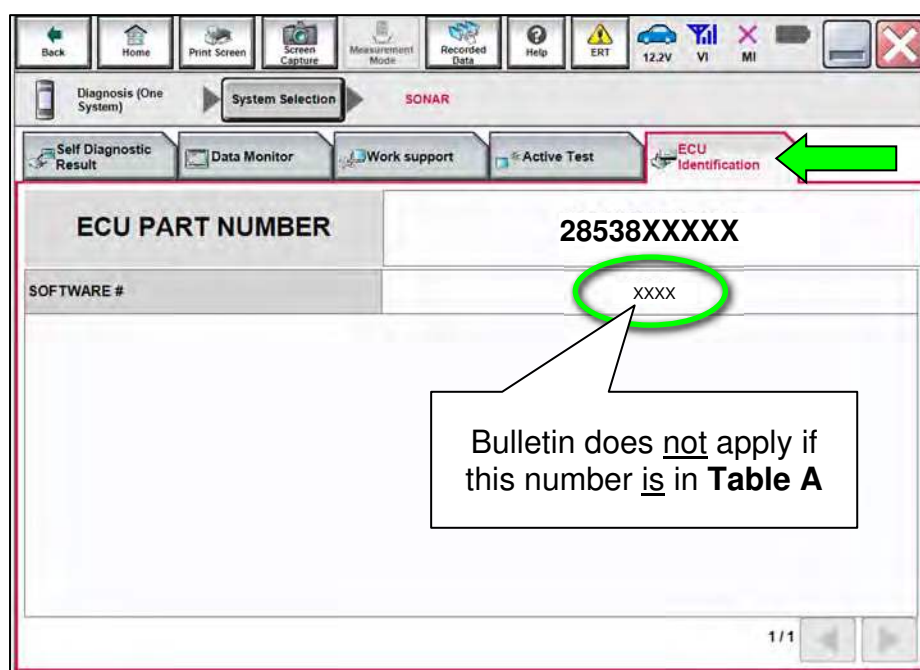
Figure 4

15. Select **ECU Identification**.
16. Confirm the current **SOFTWARE #** (Figure 4). See **Table A** (below) for model specific **SOFTWARE #**.
  - If the **SOFTWARE #** is in **Table A**, this bulletin does not apply. See the Electronic Service Manual (ESM) for further diagnostic information.
  - If the **SOFTWARE #** is not in **Table A**, proceed to step 17.

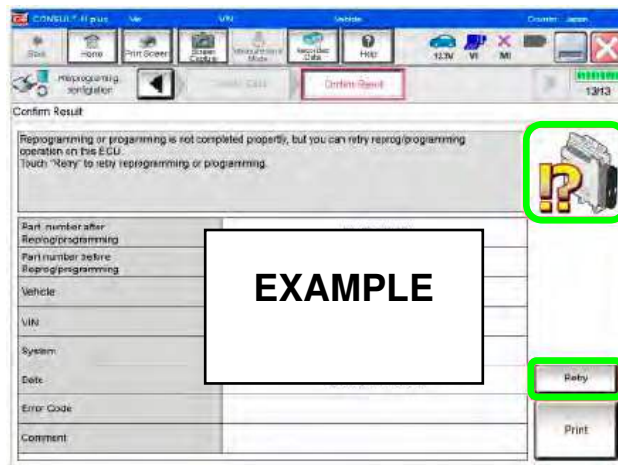
Figure 21

**If reprogramming does not complete and the “!?” icon displays, as shown in Figure 21:**

- Check battery voltage (12.0 - 13.5 V).
- Ignition is ON, engine OFF.
- External Bluetooth® devices are OFF.
- **All** electrical loads are OFF.
- **Select retry and follow the on screen instructions.**
- **“Retry” may not go through on first attempt and can be selected more than once.**

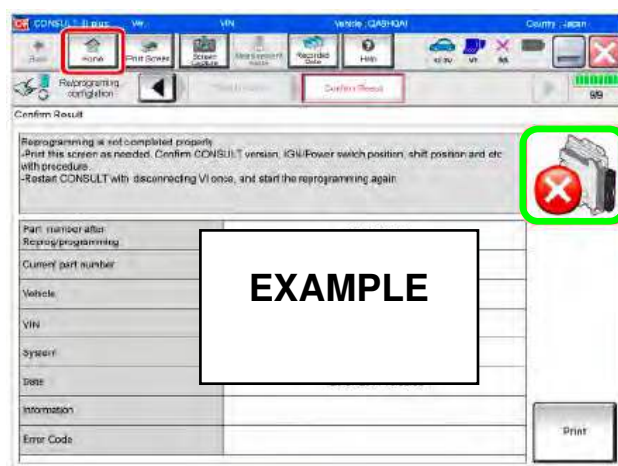
Figure 22

**If reprogramming does not complete and the “X” icon displays, as shown in Figure 22:**

- Check battery voltage (12.0 - 13.5 V).
- CONSULT A/C adapter is plugged in.
- Ignition is ON, engine OFF.
- Transmission is in Park.
- All CONSULT VI cables are securely connected.
- All C-III plus updates are installed.
- **Select Home, and restart the reprogram procedure from the beginning.**

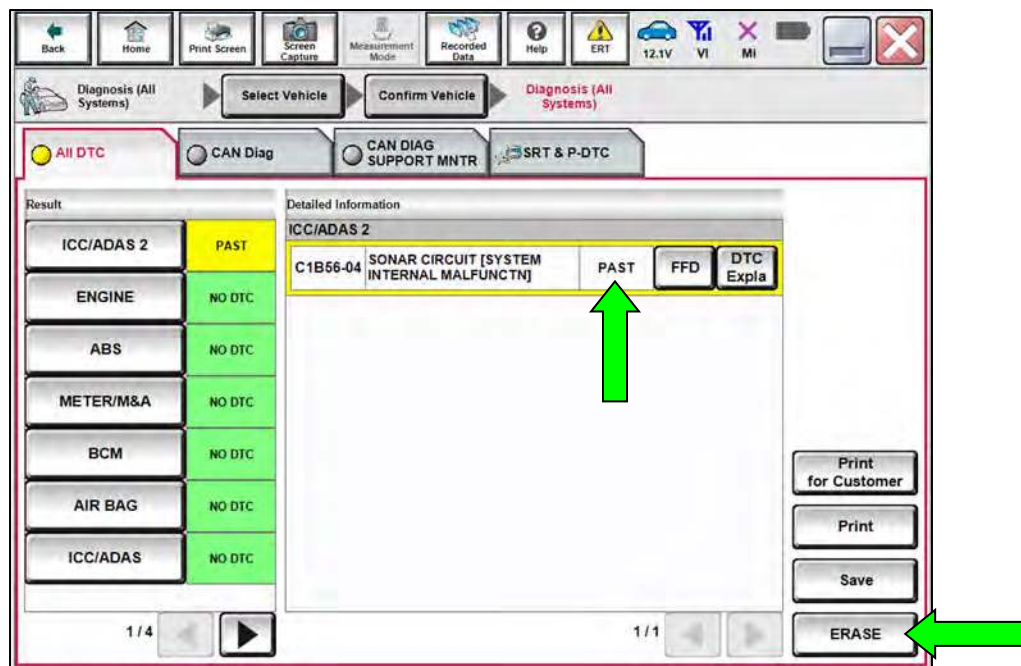
Figure 38

64. Select **Automatic Selection(VIN)**.
65. Select **Confirm**.
66. Select **Confirm**, again.
67. Turn the ignition OFF, and then turn the ignition ON.
68. Confirm DTC C1B56-04 is displayed as **PAST** (not **CRNT**) (Figure 38).
69. Select **ERASE**.
