# TECHNICAL SERVICE BULLETIN

DA22-004B

NTB22-073B

## REAR AUTOMATIC BRAKING WARNING LIGHT ILLUMINATED AND/OR DTC C1B56-04 AND/OR C1B56-97 STORED IN THE ADAS CONTROL UNIT

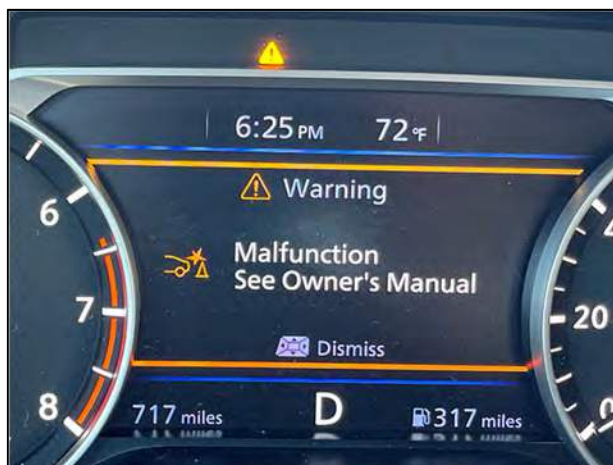
Figure 1

The customer states the rear automatic braking (RAB) warning light is illuminated, with "Malfunction See Owner's Manual" appearing in the vehicle information display,

DTC C1B56-04 for "SONAR CIRCUIT" and/or C1B56-97 for "SONAR CIRCUIT" is stored in the ADAS Control Unit.

Reprogram and configure the Sonar Control Unit using the **SERVICE PROCEDURE** in this bulletin, if applicable.

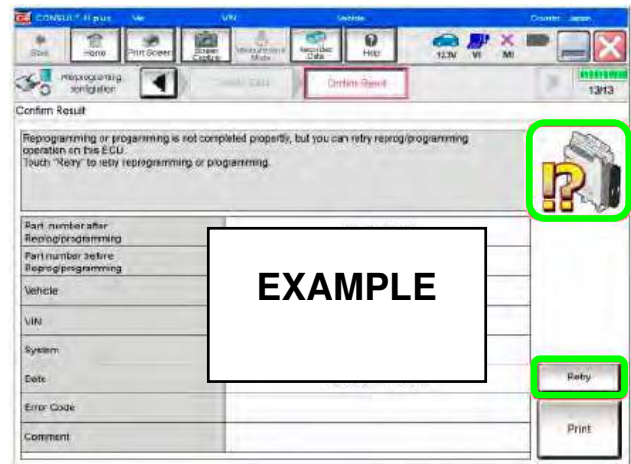
Figure 22

**If reprogramming does not complete and the “!” icon displays, as shown in Figure 22:**

- Check battery voltage (12.0 - 13.5 V).
- Ignition is ON, engine OFF.
- External Bluetooth® devices are OFF.
- **All** electrical loads are OFF.
- **Select retry and follow the on screen instructions.**
- **“Retry” may not go through on first attempt and can be selected more than once.**

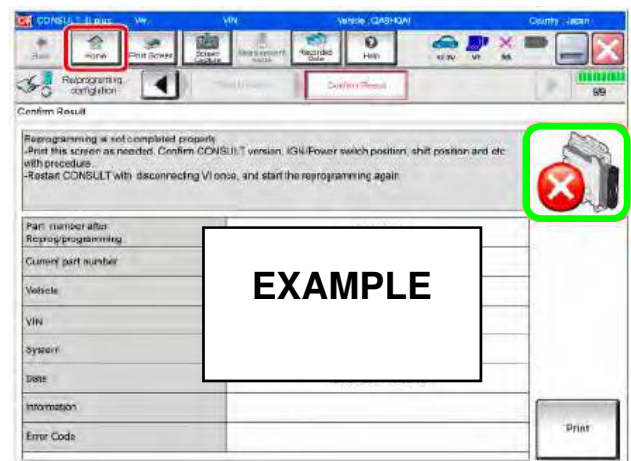
Figure 23

**If reprogramming does not complete and the “X” icon displays, as shown in Figure 23:**

- Check battery voltage (12.0 - 13.5 V).
- CONSULT A/C adapter is plugged in.
- Ignition is ON, engine OFF.
- Transmission is in Park.
- All CONSULT VI cables are securely connected.
- All C-III plus updates are installed.
- **Select Home, and restart the reprogram procedure from the beginning.**
