# TECHNICAL SERVICE BULLETIN

| EL22-015A | NTB23-024A | May 10, 2024 |

## VEHICLE WILL NOT START AND DTCS P31E7 AND P0AA6 STORED IN EV/HEV CONTROL MODULE

**APPLIED VEHICLES:** 2019-2025 LEAF (ZE1)  
**APPLIED SYSTEMS:** 62 kWh Battery Pack (4th Character of the VIN is B or C)

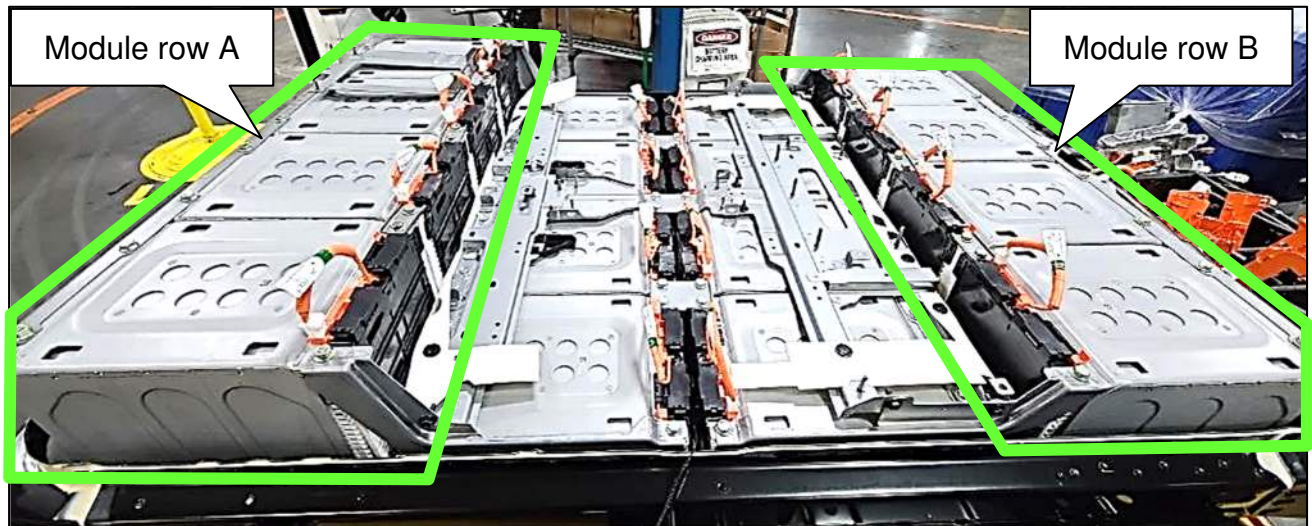
Figure 1

1. Perform ESM diagnosis for DTCs to determine which Li-Ion battery module has caused the DTC.
  - The affected module will only be in module row A or B (Figure 1).

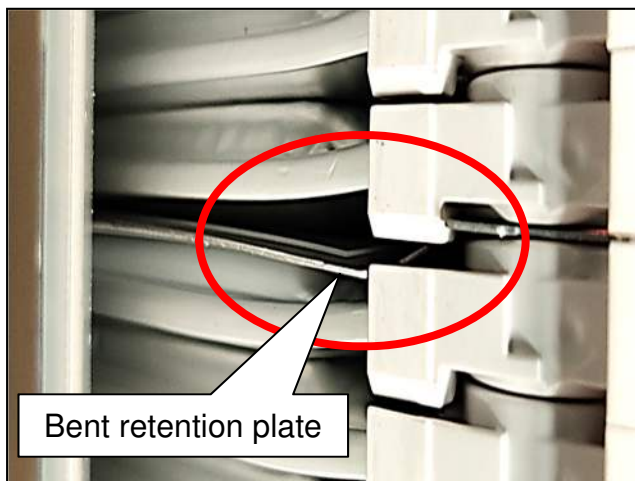
Figure 2

2. Remove and inspect the affected Li-Ion battery module for a bent retention plate.
  - If a Li-Ion battery module has a bent retention plate (**Error! Reference source not found.**), replace the Li-Ion battery module.
    - Refer to the ESM: **ELECTRIC POWER TRAIN > EV BATTERY SYSTEM > 62kWh LI-ION BATTERY > DISASSEMBLY AND ASSEMBLY > MODULE > MODULE : Disassembly & Assembly**
  - IMPORTANT:** Make sure to follow all Dangers, Warnings, Cautions, and additional work procedures outlined in the ESM.
  - If the Li-Ion battery module does not have a bent retention plate (Figure 3), this bulletin does not apply. Refer to ASIST for further diagnosis.
