| REFERENCE: | TSB: 08-166-24<br>GROUP: 08 - Electrical | Date: | July 19, 2024 | REVISION: | — |
| VEHICLES AFFECTED: | 2023 (M6) Jeep Compass<br>2023 (MP) Jeep Compass<br>2023 (MV) Jeep Compass<br>This bulletin applies to vehicles equipped with the Surround View Camera System (Sales Code XAK). | | | MARKET APPLICABILITY:<br><div><input checked="" type="checkbox"/> NA<input type="checkbox"/> MEA</div> <div><input type="checkbox"/> SA<input checked="" type="checkbox"/> IAP</div> <div><input checked="" type="checkbox"/> EE<input type="checkbox"/> CH</div> | |

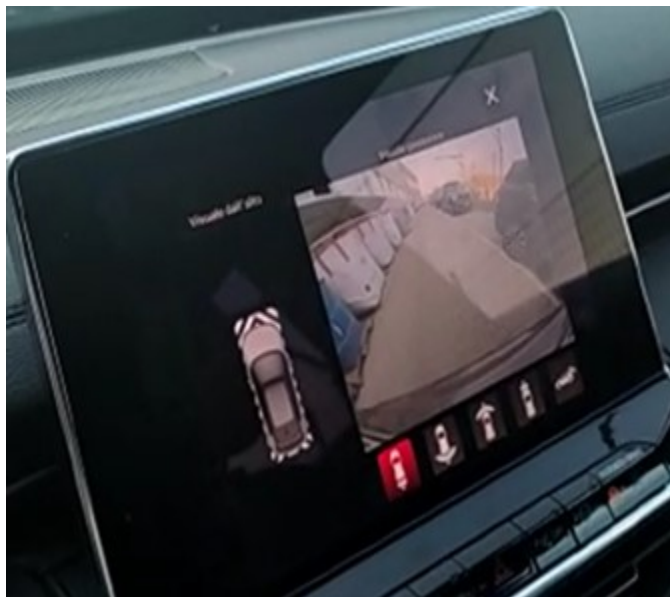
| CUSTOMER SYMPTOM: | Customers must experience a Malfunction Indicator Lamp (MIL) illumination and the vehicle must exhibit/set one or more of the following Diagnostic Trouble Codes (DTCs): <ul style="list-style-type: none"><li>● B2286-00 - Calibration Not Learned - Lost Calibration.</li><li>● B223B-00 - Vehicle Configuration Mismatch.</li></ul> Customers may also comment on the following: <ul style="list-style-type: none"><li>● Top-down camera view is blank when camera view is selected in the radio menu.</li><li>● Odometer is flashing.</li><li>● No backup camera gridlines when vehicle transmission is in reverse <a href="#">Fig. 1</a>.</li></ul> | | | | |
| CAUSE: | CVPM software update | | | | |

**Fig. 1**  
Missing Gridlines When In Reverse Gear

This bulletin involves updating the CVPM with the latest available software.

1. Reprogram the CVPM with the latest software. If issues arise when flashing a module using the wiTECH Diagnostic Application, please submit a ticket to the Helpdesk. The helpdesk can be found within the Help menu.
2. Perform the PROXI Configuration Alignment routine located in the Guided Diagnostics menu.
3. Clear all DTCs that may have been set in any module due to reprogramming. The wiTECH application will automatically present all DTCs after the flash and allow them to be cleared.
