# MIL ON With DTC P279762

**Service**  
**Category** Drivetrain

**Section** Hybrid Transmission/Transaxle

Some 2023 – 2024 model year RX 500h and 2024 model year TX 500h vehicles may exhibit a MIL ON condition with Diagnostic Trouble Code (DTC) P279762 (Electromagnetic Oil Pump Component Internal Failure) present. The Transmission Control Module (TCM) logic has been modified to reduce the possibility of this condition. Follow the Repair Procedure in this bulletin to address this condition.

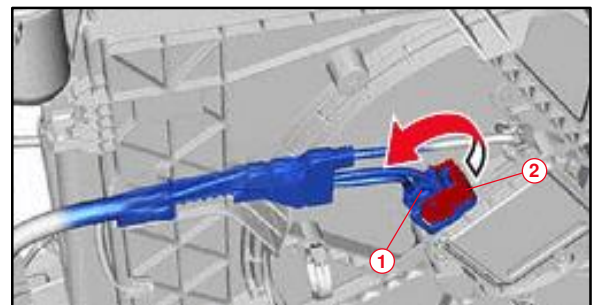
**Figure 1.**

| 1 | Cooling Fan Motor Connector |
| 2 | Lock |

- Confirm the condition exists.  
Does the vehicle exhibit a MIL ON condition with DTC P279762 (Electromagnetic Oil Pump Component Internal Failure) present?
  - YES** — Continue to step 2.
  - NO** — This bulletin does NOT apply. Continue diagnosis using the applicable Repair Manual.
- Use GTS+ to confirm if the TCM calibration has been updated.  
Is the calibration ID listed in GTS+ the latest TCM calibration?
  - YES** — This bulletin does NOT apply. Continue diagnosis using the applicable Repair Manual.
  - NO** — Continue to step 3.
- Disconnect the cooling fans.
  - Disconnect the cooling fan motor connector.
  - Rotate the lever while pushing the lock and disconnect the cooling fan motor connector.

After disconnecting the cooling fan motor connector, make sure that dirt, water, or other foreign matter does NOT contact the connecting parts of the cooling fan motor connector.

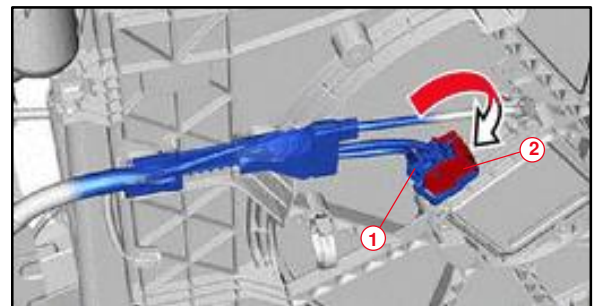
**Figure 2.**

| 1 | Cooling Fan Motor Connector |
| 2 | Lock |

5. Reconnect the cooling fans.
  - A. Connect the cooling fan motor connector.
  - B. Rotate the lever to lock it.

- When connecting the cooling fan motor connector, make sure that the connecting parts of the cooling fan motor connector are free of dirt, water, or other foreign matter.
- Be sure to securely connect the cooling fan motor connector.
