# DTC U010087 & No Start/ Replaced Engine ECU After Jump Starting / Replaced Engine ECU After Jump Starting

A25A-FXS

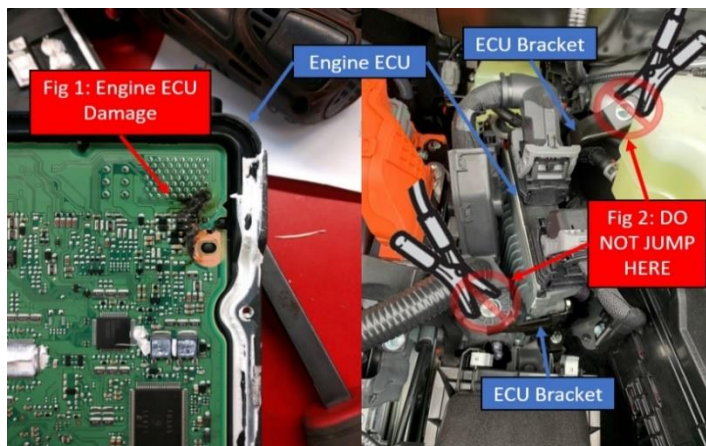
After jump-starting, the vehicle may experience a no-start condition and multiple DTCs including U010087. Upon investigation, it is found that the engine ECU has been damaged and needs to be replaced (Fig 1). In several cases, it was found that the cause of the ECU damage was improper jump starting. Further investigation found that ECU damage may occur if the negative (ground) cable clamps are attached on or around the engine ECU or ECU mounting bracket (Fig 2).

To prevent this condition from occurring, it is recommended that the jumper cables be attached as described in the owner's manual. Below is an example of the correct jump start locations for 22 MY Highlander HV (Fig 3). Please consult the appropriate owners or repair manual to confirm the correct jump start location on other models.

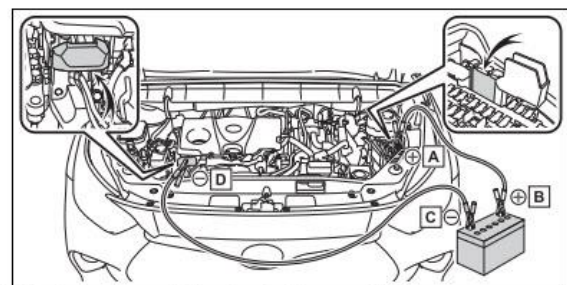
- A Exclusive jump starting terminal (your vehicle)
- B Positive (+) battery terminal (second vehicle)
- C Negative (-) battery terminal (second vehicle)
- D Solid, stationary, unpainted metallic point away from the exclusive jump starting terminal and any moving parts as shown in the illustration
