# Technical Service Bulletin

**97 MIL on - DTC: U060B00 stored in engine control unit**  
01 24 29 2074392/1 July 3, 2024.

| Model(s) | Year | VIN Range | Vehicle-Specific Equipment |
|---|---|---|---|
| Q5, Q5 e quattro, Q5 Sportback, SQ5, and SQ5 Sportback | 2022 - 2024 | All | Not Applicable |

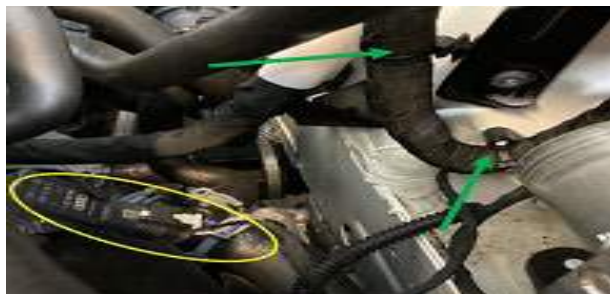
**Figure 1: G31 and connector**

Under certain conditions, vibrations may cause the wiring on electrical connector T3y to break.

Check wiring on electrical connector T3y for charge pressure sender -G31- for damage (see yellow circle on figure 1).

Disconnect electrical connector T91 on the engine control unit and loosen the wiring harness at the two mounting points (green arrows in Figure 1) to gain better access.

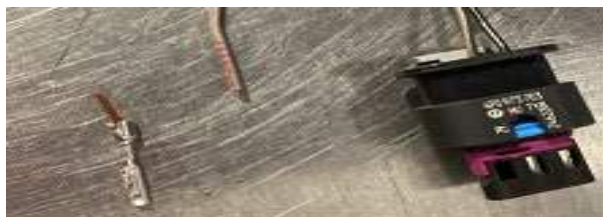
The damage may only be noticeable after de-pinping the connector or removing the harness tape.

**Figure 2:** Wire damaged inside G31 connector
