# Technical Service Bulletin

**01 MIL on - Intake manifold - electric changeover valve N316 - P2004, P2006, P2014, P2015 - 4-cyl. 2.0 ltr. TFSI**

01 24 31 2072273/2 July 18, 2024. Supersedes Technical Service Bulletin Group 01 number 23-02 dated December 1, 2023 for reasons listed below.

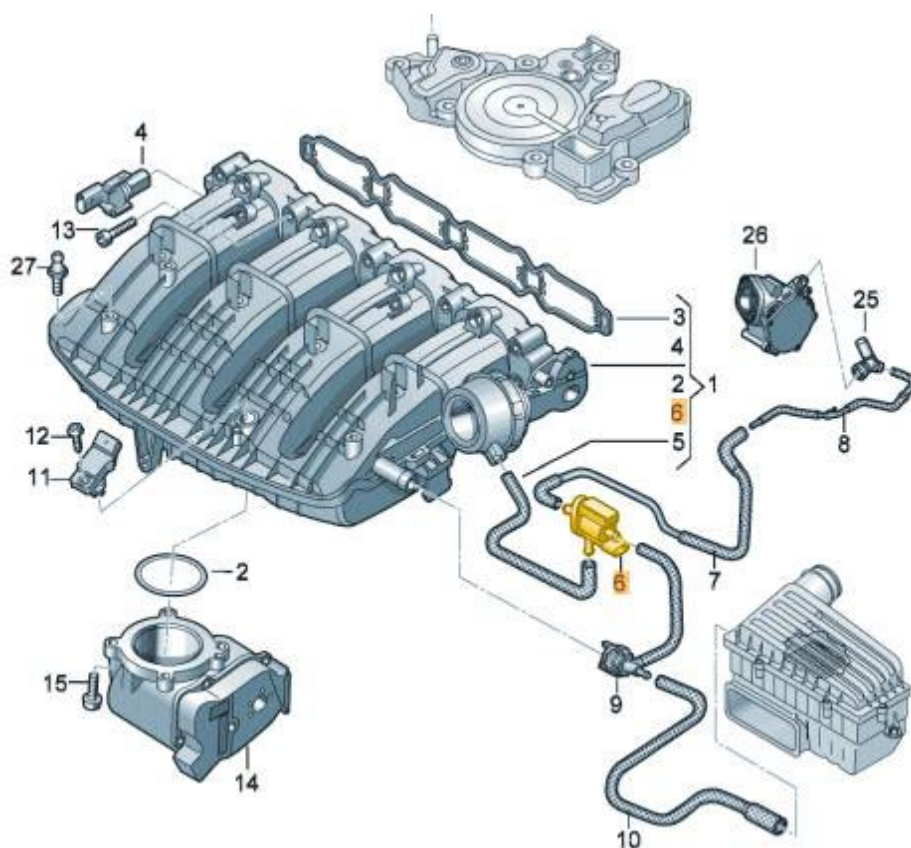
The electric changeover valve (N316) may be sticking.

Replace electric changeover valve (refer to extract from ETKA, component 6):
