# Technical Service Bulletin

## 34 Function restriction with event memory entry P071800 - P276800 (symptom 20736 - 20737)

34 24 69 2067653/8 July 3, 2024. Supersedes Technical Service Bulletin Group 34 number 24-68 dated June 3, 2024 for reasons listed below.

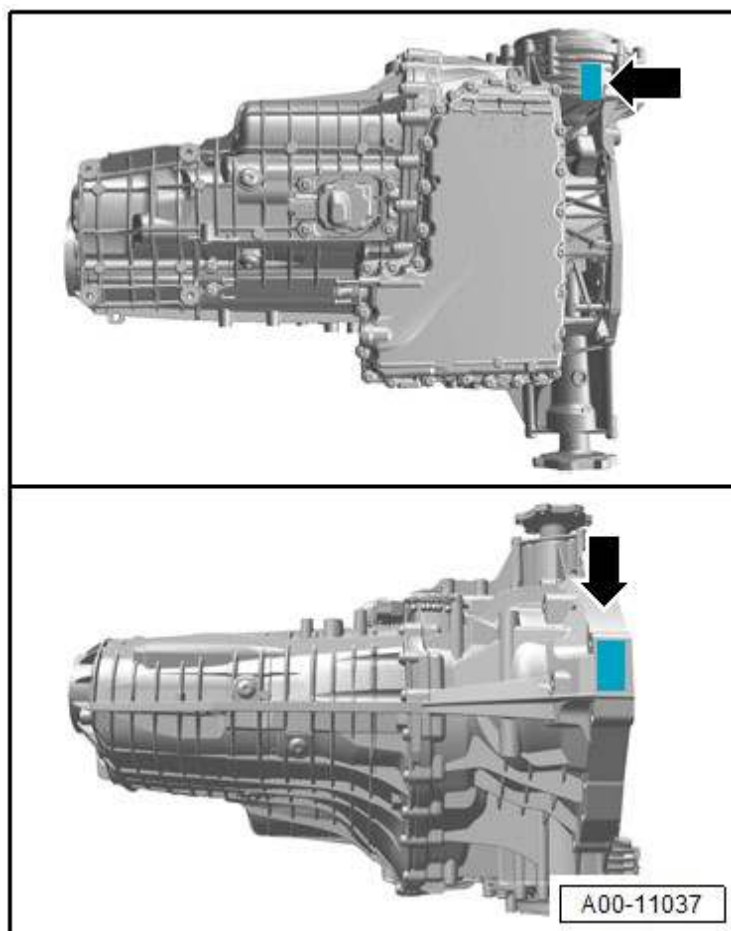
- **First determine if the Transmission was built within the date range of June 15, 2020, and November 30, 2023.**
- Check one of the transmission data stamps which are located on the bottom of the front differential and the top of the bell housing (Figure 1).

**Figure 1.** Locations of data stampings.
