# Technical Service Bulletin

## 93 e-tron GE electric drive motor leak P0AA600

93 24 82 2073858/1 July 27, 2024.

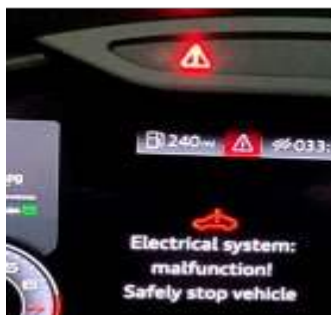
A Drive System/Electrical System Malfunction message (Figure 1) appears in the in the instrument cluster; the warning may not be present at the time of inspection.

Figure 1. Warning lamp associated with message.

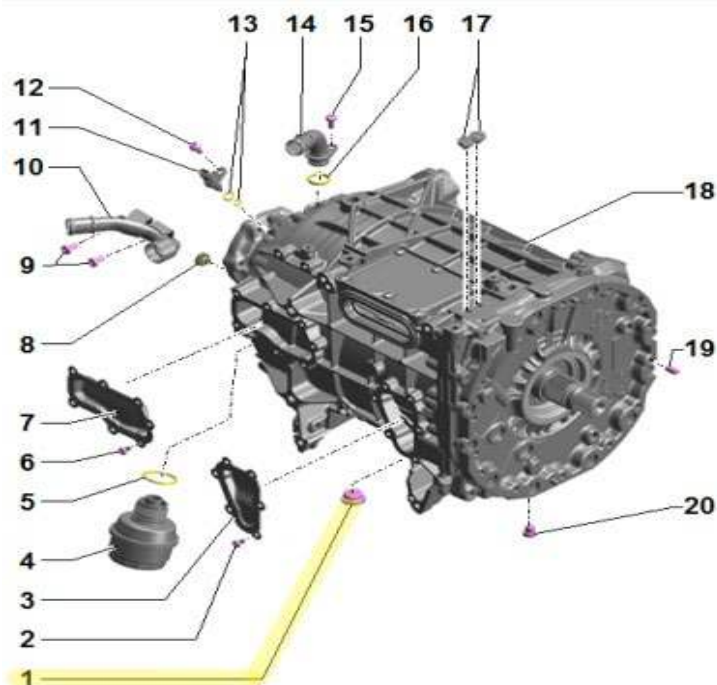
Drip container is overflowing:

Coolant leaking from active chamber.

Drip container is empty:

Coolant leaking from active chamber, particularly on vehicles with low mileage.

**Figure 2:** (1) Drain plug.

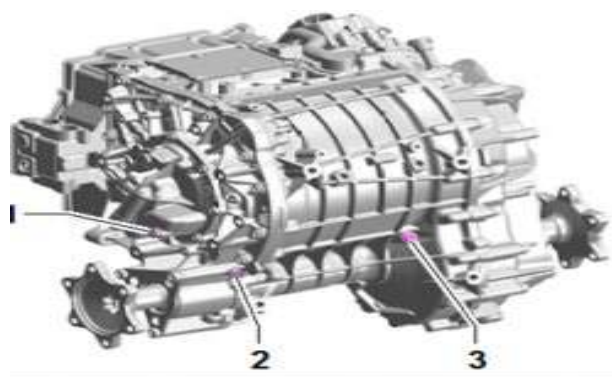
Coolant leaking from active chamber.

**Figure 3:** 1) *Resolver cover:* A few milliliters of coolant leakage is not an issue from a technical perspective. 2) *Active chamber:* No coolant may escape from the bores.

**The power electronics for electric drive must not be replaced if the electric drive motor is leaking (refer to images 4 and 5).**

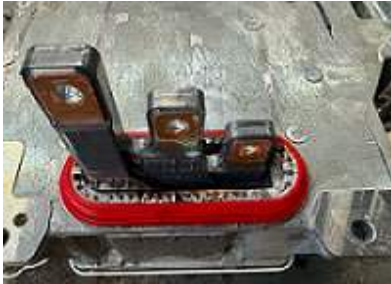
1) Corrosion on the high-voltage system connection for power and control electronics for electric drive (Figure 4).

**Figure 4:** Corrosion on high-voltage system connection for power and control electronics for electric drive.

**In this case, the power and control electronics for electric drive must not be replaced.**

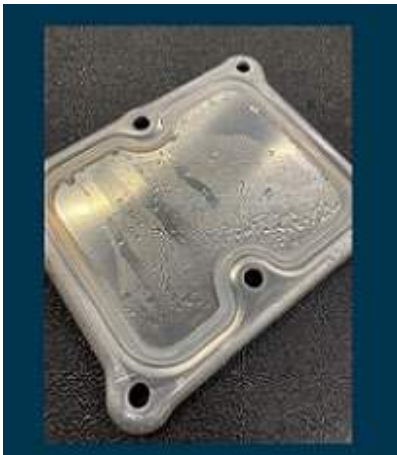
2) Condensation on high-voltage system connection cover (Figure 5).

**Figure 5:** Condensation on high-voltage system connection cover.
