# Technical Service Bulletin

**96 Warning for lane change, exit warning, Audi pre sense or rear cross-traffic assist, DTC: U104500, U10BA00, U160F00**

96 24 01 2074670/1 July 27, 2024.

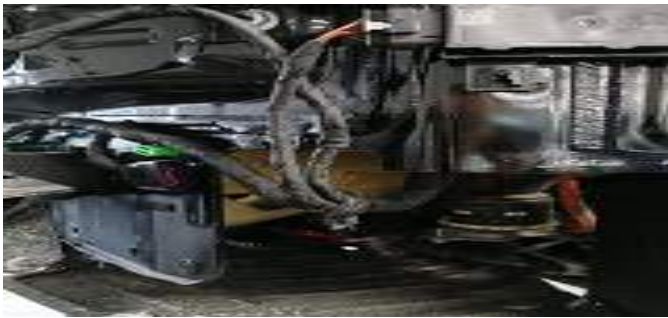
Wiring damaged due to environmental influences.

**Figure 1:** *Wiring behind the bumper.*

Check the wiring in the rear right of vehicle behind the bumper (see Figure 1).

Inspect the area between the body grommet and the lane change assist control unit -J769-.

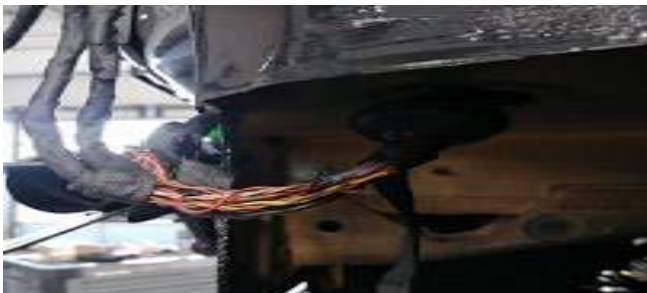
The damage may not be visible from the outside. Check the wiring beneath the wrapping (see Figure 2).

**Figure 2:** *Wiring beneath the wrapping.*

Repair the harness using wiring harness repair set **VAS 1978 B/C**.
