| <b>HYUNDAI</b><br><b>Technical Service Bulletin</b> | GROUP<br><b>ENGINE</b> | NUMBER<br><b>24-EM-001H</b> |
| | DATE<br><b>JULY 2024</b> | MODEL(S)<br><b>SONATA (DN8a)<br/>SANTA FE (TMa)<br/>TUCSON (NX4a)</b> |
| <b>SUBJECT:</b> DTC P2181 – INTEGRATED THERMAL MANAGEMENT (ITM) REPLACEMENT | | |

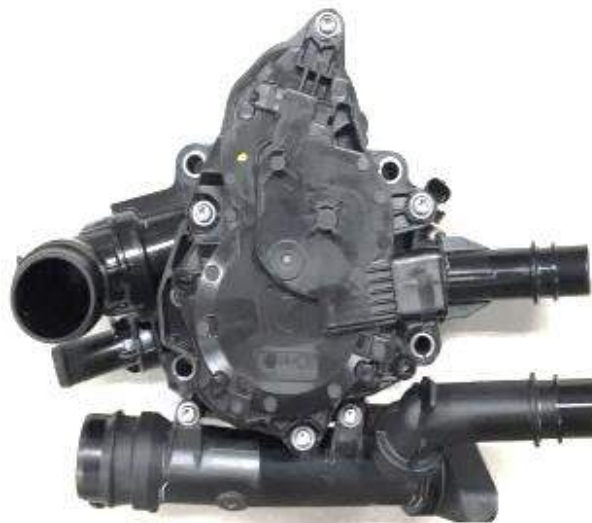
**Description:** Certain 20-22MY Sonata (DN8a), 21-23MY Santa Fe (TMa), and 22-23MY Tucson (NX4a) vehicles may experience a warning lamp illumination for a diagnostic trouble code P2181 that is related to the Integrated Thermal Management Module (ITM). Follow the service procedure outlined in this bulletin to replace the ITM.

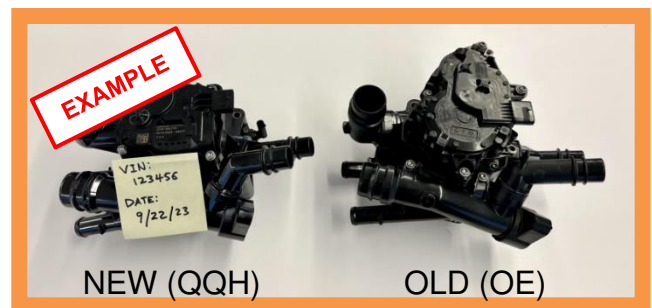
Before installing the new ITM, take a STUI photo of the QQH part next to the removed old part.
