## PIP5978 Diagnostic Tip: DTC P0299 Set As Current Or In History

Proactive  
Models

| Condition: | DTC P0299 Set as current or in history |

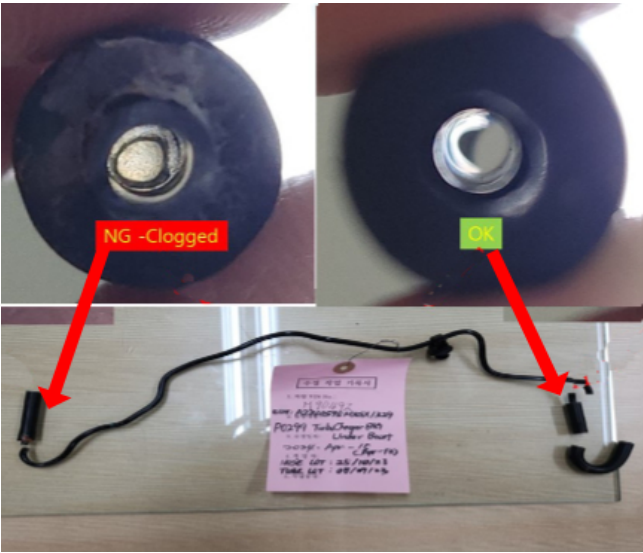
| Cause: | Possible restriction within vacuum supply hose between vacuum pump and wastegate solenoid |

If unable to isolate the root cause remove the vacuum supply hose that attaches to the wastegate solenoid and vacuum pump assembly to inspect for potential restriction in the hose ends caused by adhesive bonding material.

Reference the picture below which shows the complete hose assembly and both hose ends.

If the above condition is found then replace the vacuum hose assembly using the latest parts listed in EPC.
