Bulletin No.: PIP5974A  
Published date: N/A

## PIP5974A GF9 9T45/50/60/65 Transmission 1-2-3-4-5-6 Clutch Snap Ring Popout Causing SES / DTC Code P0746 P0747

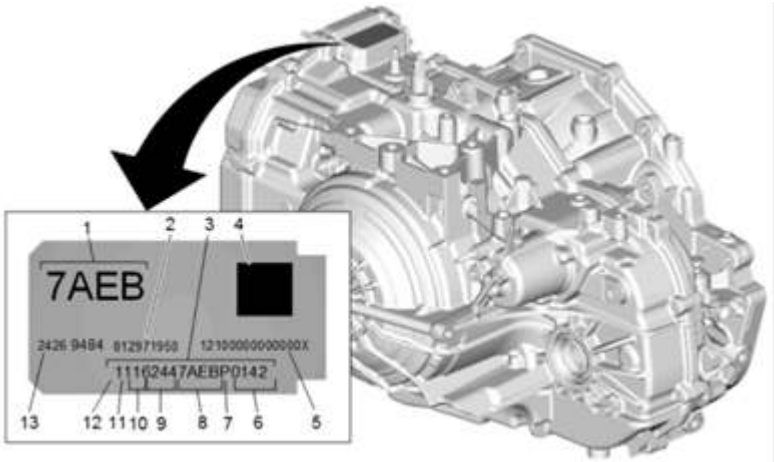
| Condition | <p>Some Buick, Cadillac, Chevrolet and GMC vehicles equipped with the GF9 9T45/50/60/65 automatic transmission may experience: a SES light on with code P0746 or P0747. This may be accompanied by no drive or slipping drive condition.</p> <p>These transmissions will be built between 10/1/2023 and 4/22/2024</p> <p>Julian date between 23 274 and 24 113</p> <div></div> |

| | <div>1. Broadcast Code</div> <div>2. Source DUNS Number</div> <div>3. Transmission Unique Number (TUN)</div> <div>4. 2D Machine Readable Matrix</div> <div>5. VPPS Code</div> <div>6. Part Sequence Number</div> <div>7. Site ID</div> <div>8. Broadcast Code</div> <div>9. Julian Date</div> <div>10. Year of Build</div> <div>11. Shift ID</div> <div>12. Line Plant ID</div> <div>13. GM Part Number</div> |

Check transmission Julian build date.

If the transmission is built between 10/1/2023 and 4/22/2024; Julian date between 23 274 and 24 113 and the vehicle comes in with a code P0746 or P0747 and the code resets on a short test drive or the vehicle slips in drive, the transmission will need to be disassembled and inspected for damage.
