# Preliminary Information

## PIP5932C Information on Malfunction Indicator Lamp (MIL) Illuminated with Any Combination of DTCs P0521, P06DD or P06DE Setting

| Condition | MIL on with P0521 and/or P06DD, P06DE stored. |
| Cause | Several potential causes - oil pump debris - engine wiring harness issue. |

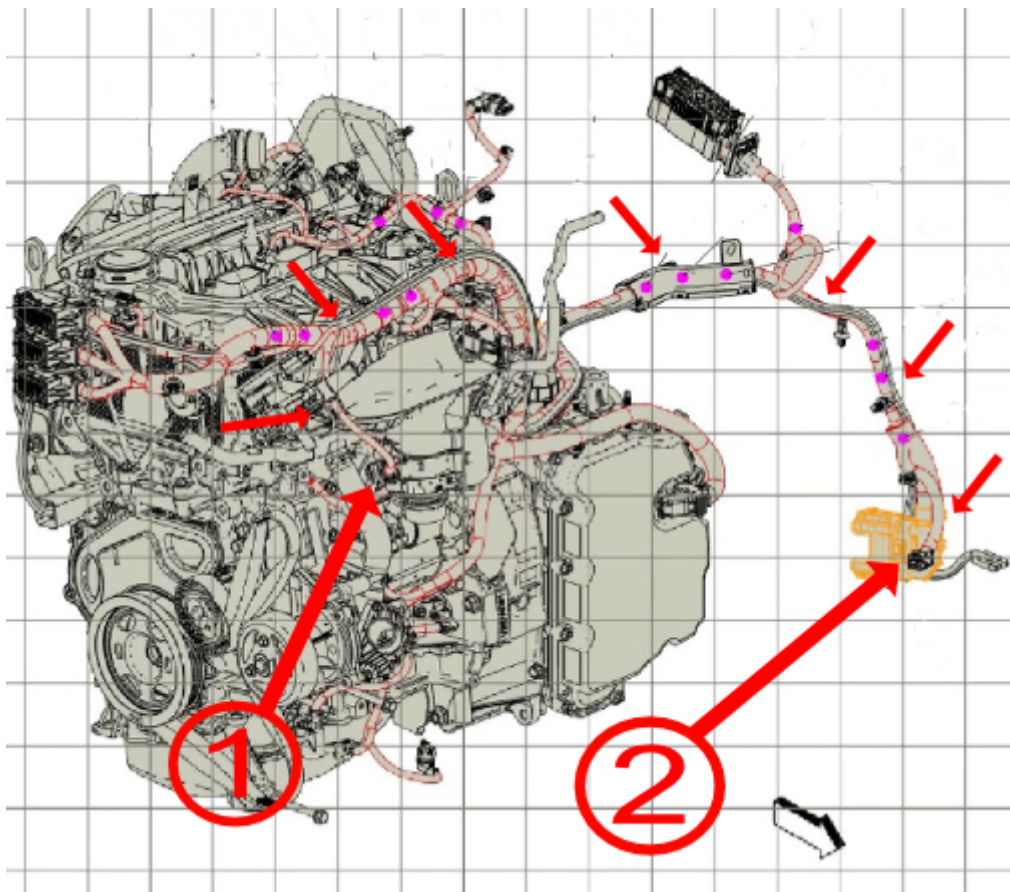
If the resistance is within range, tap and manipulate the engine wiring harness between the oil pressure sensor (1) and X125 (2) shown below, while monitoring for a change in the resistance reading.

If the concern is not isolated to the engine wiring harness, reinstall all components and if P0521, P06DD, P06DE are not set during this test, No further action is required, Release the vehicle to the customer.

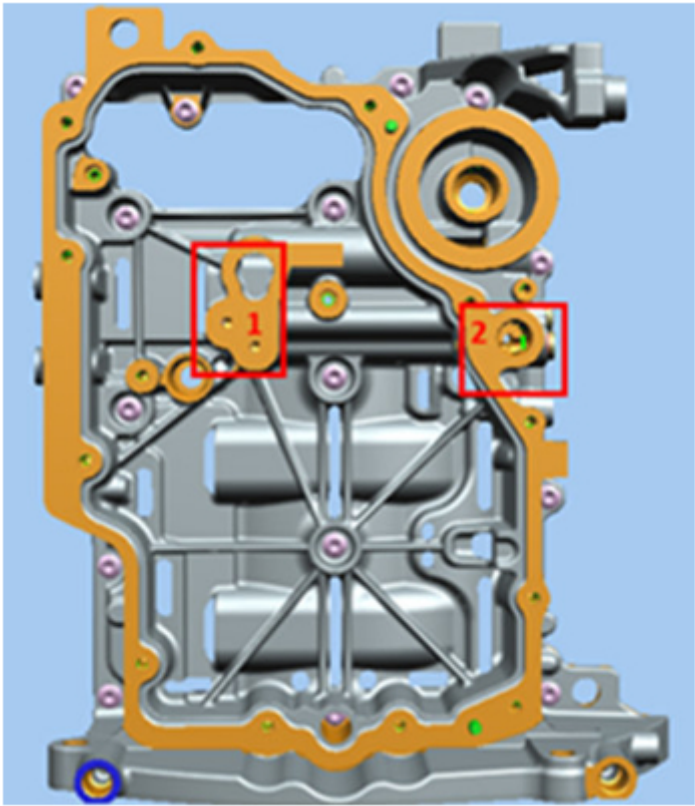
Caution: If oil pump replacement is needed, ensure the three oil pump oil holes (Area 1) and OCV mounting hole (Area 2) are free of debris BEFORE installing the oil pump and OCV. If debris is found, remove with a lint-free cloth or brush that will not scratch the surface.
