PIP5927A Diagnostic Tip: Possible DTC P0237 P0101 P1101 or P0299 Reduced Power Potential Damage To Charge Air Inlet Hose At Turbocharger

| Brand: | Model: | Model Years: | VIN: | | Engine: | Transmissions: |
|---|---|---|---|---|---|---|
| Chevrolet | Equinox | 2023 - 2024 | All | All | 1.5 LSD | All |
| GMC | Terrain | 2023 - 2024 | All | All | 1.5 LSD | All |

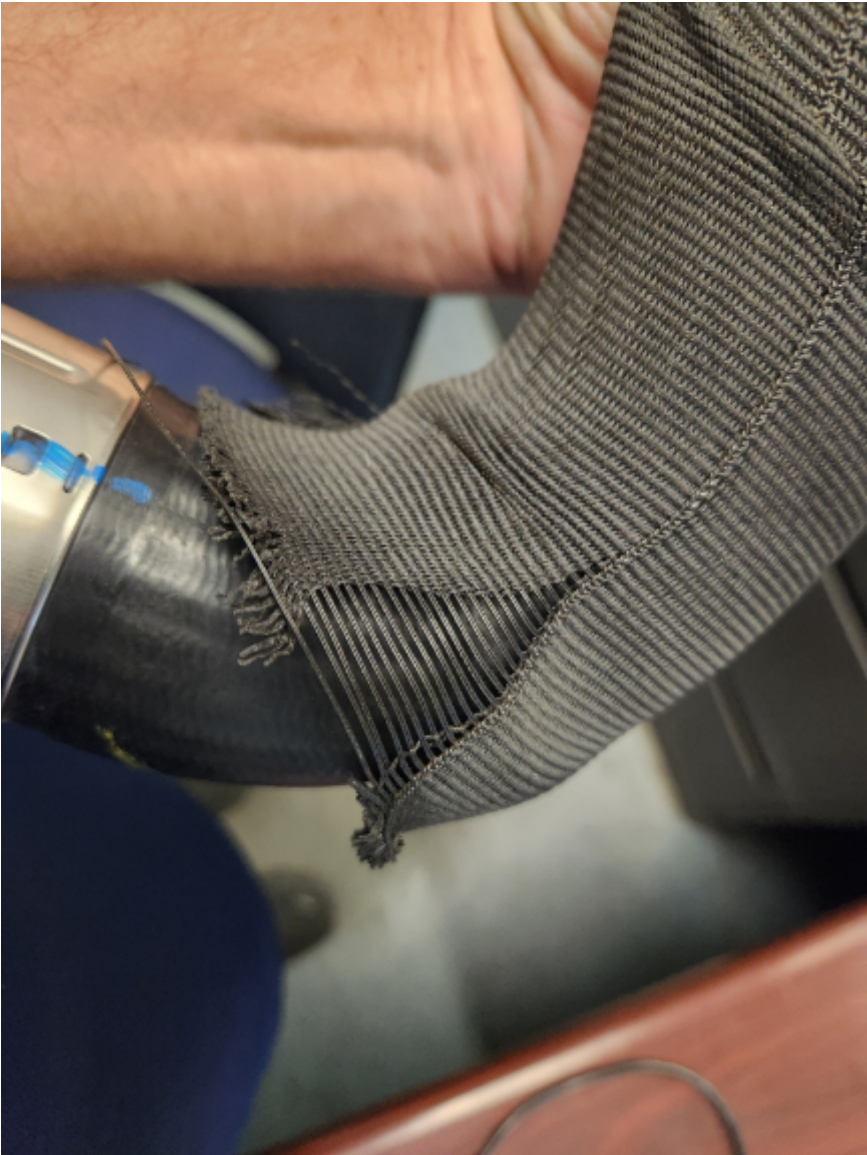
This type of damage would allow the hose to swell under pressure damaging the abrasion sleeve and altering the readings within the boost control system or create a potential air leak.

Pictures below show damage to abrasion sleeve on Charge Air Inlet Hose.

**Replace Charge Air Inlet Pipe assembly using latest parts listed in EPC.**

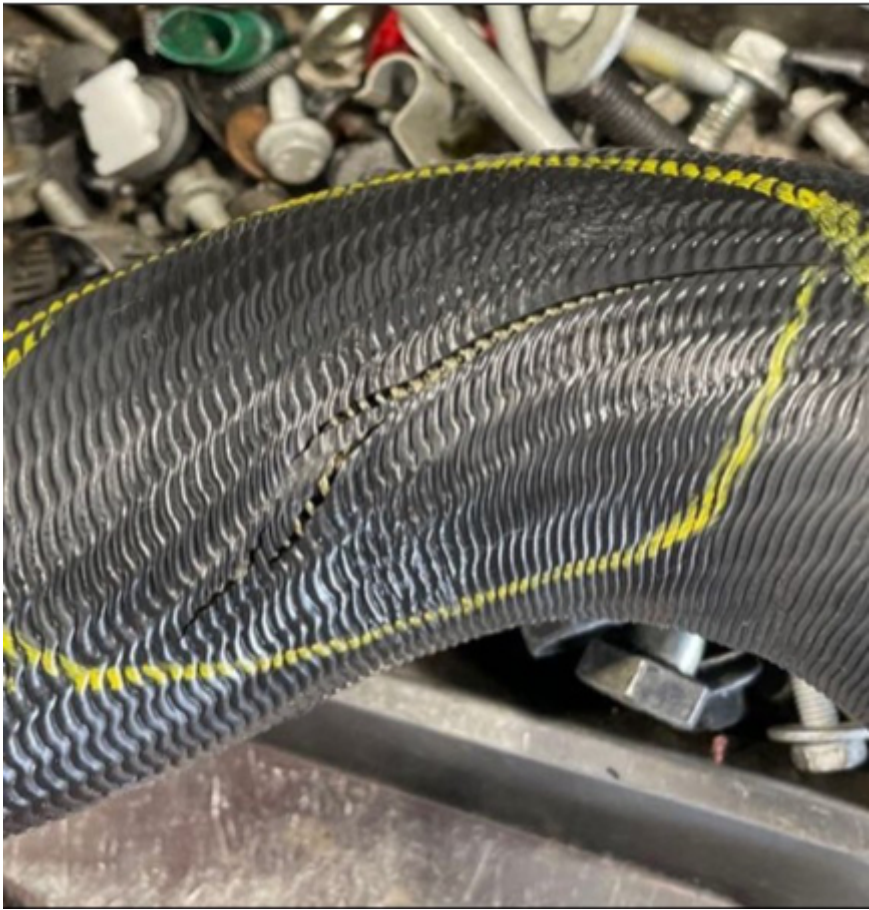
#3 Picture below inside the circled area shows damage to inner hose beneath abrasion sleeve
