# Preliminary Information

## PIP5974B GF8 8T65 Or GF9 9T45/50/60/65 Transmission 1-2-3-4-5-6 Clutch Snap Ring Popout Causing SES / DTC Code P0746 P0747

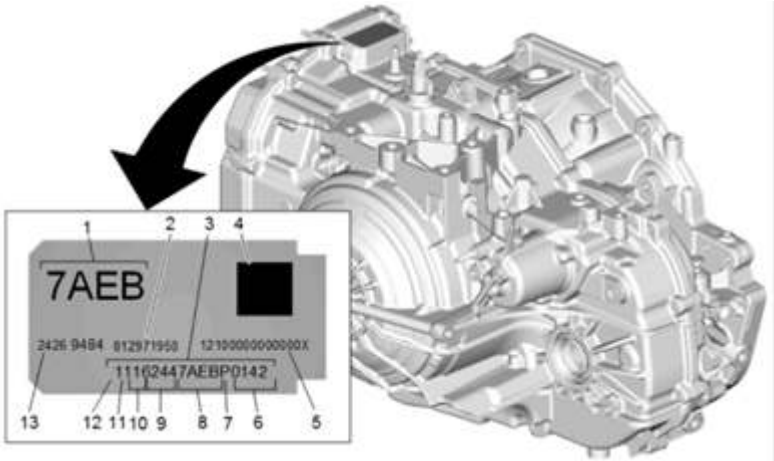
| Condition | <p>Some Buick, Cadillac, Chevrolet and GMC vehicles equipped with the GF8 8T65 or GF9 9T45/50/60/65 automatic transmission may experience: a SES light on with code P0746 or P0747.</p> <p>This may be accompanied by no drive or slipping drive condition.</p> <p>These transmissions will be built between 10/1/2023 and 4/22/2024</p> <p>Julian date between 23 274 and 24 113</p> <div></div> |

| | <div>1. Broadcast Code</div> <div>2. Source DUNS Number</div> <div>3. Transmission Unique Number (TUN)</div> <div>4. 2D Machine Readable Matrix</div> <div>5. VPPS Code</div> <div>6. Part Sequence Number</div> <div>7. Site ID</div> <div>8. Broadcast Code</div> <div>9. Julian Date</div> <div>10. Year of Build</div> <div>11. Shift ID</div> <div>12. Line Plant ID</div> <div>13. GM Part Number</div> |

Check transmission Julian build date.

If the transmission is built between 10/1/2023 and 4/22/2024; Julian date between 23 274 and 24 113 and the vehicle comes in with a code P0746 or P0747 and the code resets on a short test drive or the vehicle slips in drive, the transmission will need to be disassembled and inspected for damage.

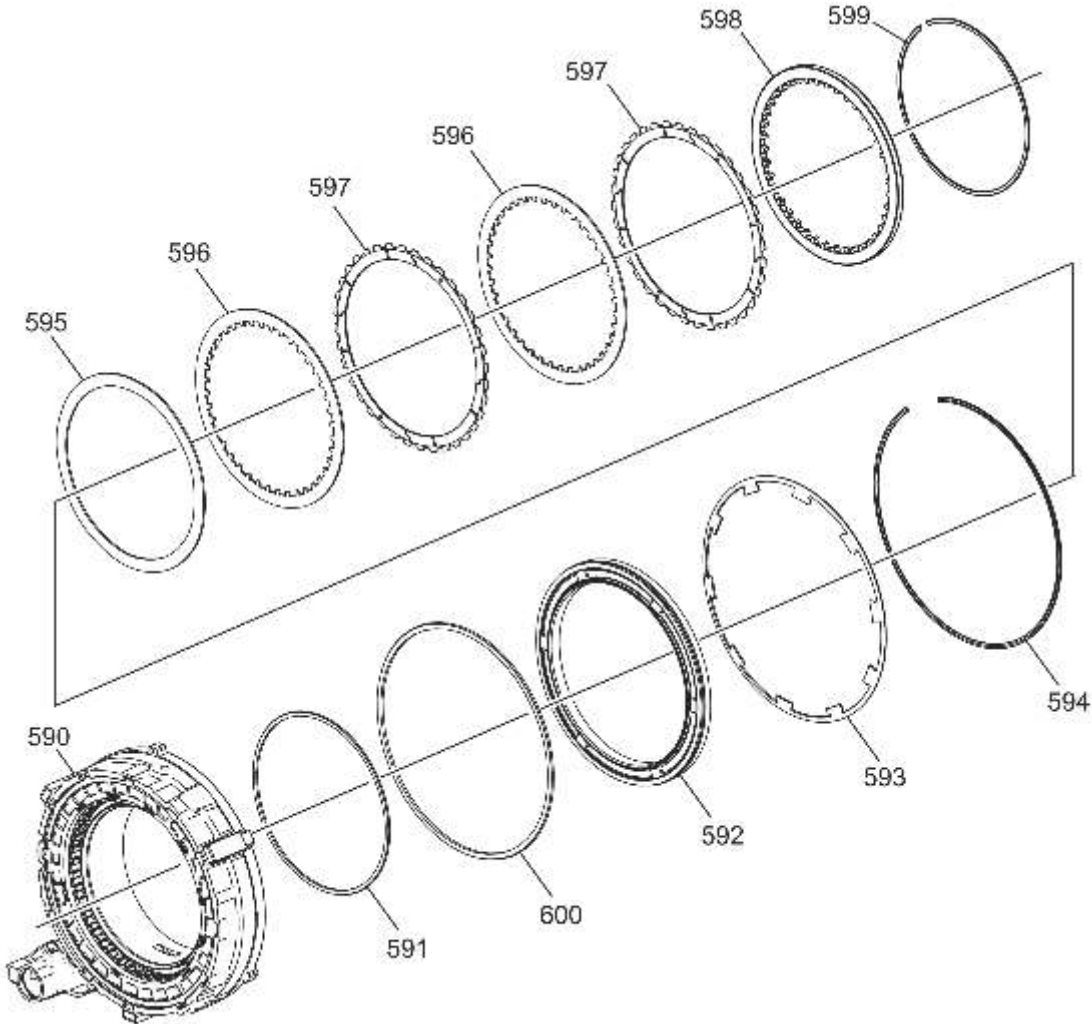
| Cause | <div>The transmission concern could be caused by an out of round snap rings: (594) 1-2-3-4-5-6 Clutch Spring Retaining Ring or (599) 1-2-3-4-5-6 Clutch Backing Plate Retaining Ring</div> <div></div> |

The following parts will need to be replaced:

- (590)1-Reverse and 1-2-3-4-5-6 Clutch Piston Housing
- (591)1-2-3-4-5-6 Clutch Piston Inner Seal
- (592)1-2-3-4-5-6 Clutch Piston
- (593)1-2-3-4-5-6 Clutch Piston Return Spring
- (594)1-2-3-4-5-6 Clutch Spring Retaining Ring
- (595)1-2-3-4-5-6 Clutch Plate - Wave
- (596)1-2-3-4-5-6 Clutch Plate
- (597)1-2-3-4-5-6 Clutch Plate - Friction
- (598)1-2-3-4-5-6 Clutch Backing Plate
- (599)1-2-3-4-5-6 Clutch Backing Plate Retaining Ring
- (600)1-2-3-4-5-6 Clutch Piston Seal
