# Preliminary Information

## PIP5932D Information on Malfunction Indicator Lamp (MIL) Illuminated with Any Combination of DTCs P0521, P06DD or P06DE Setting

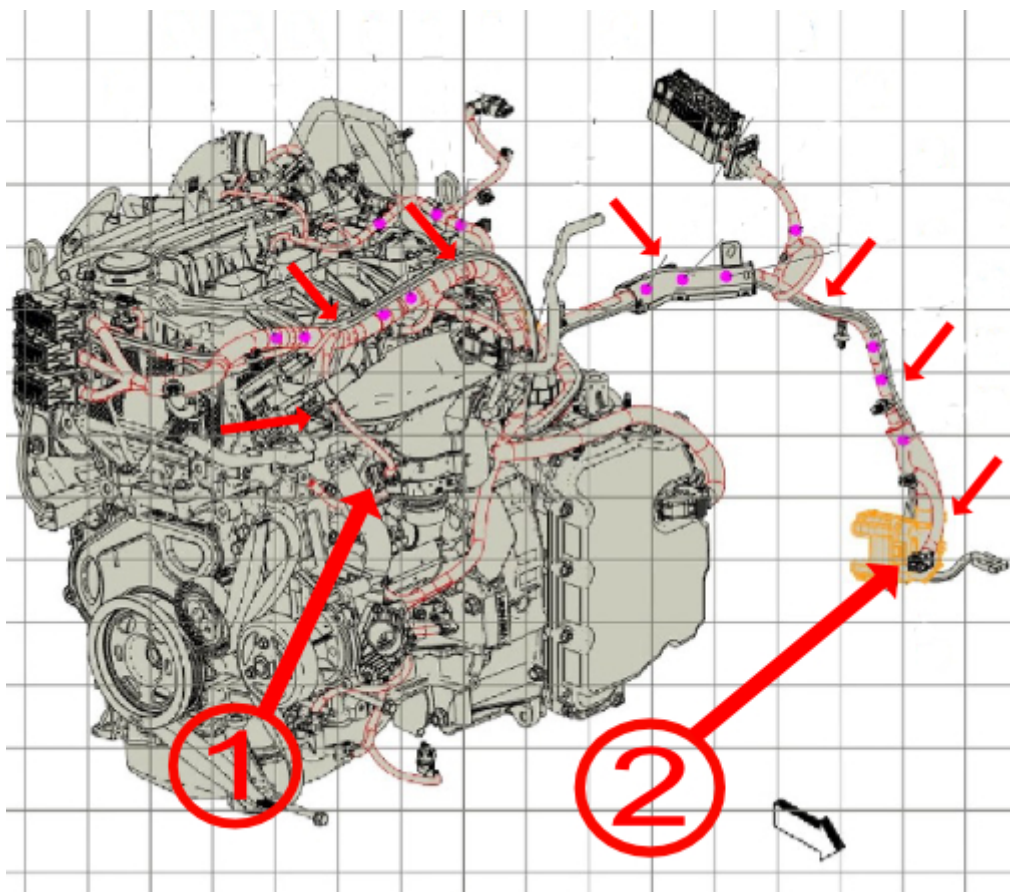
If the resistance is within range, tap and manipulate the engine wiring harness between the oil pressure sensor (1) and X125 (2) shown below, while monitoring for a change in the resistance reading.

If the concern is not isolated to the engine wiring harness, reinstall all components and if P0521, P06DD, P06DE

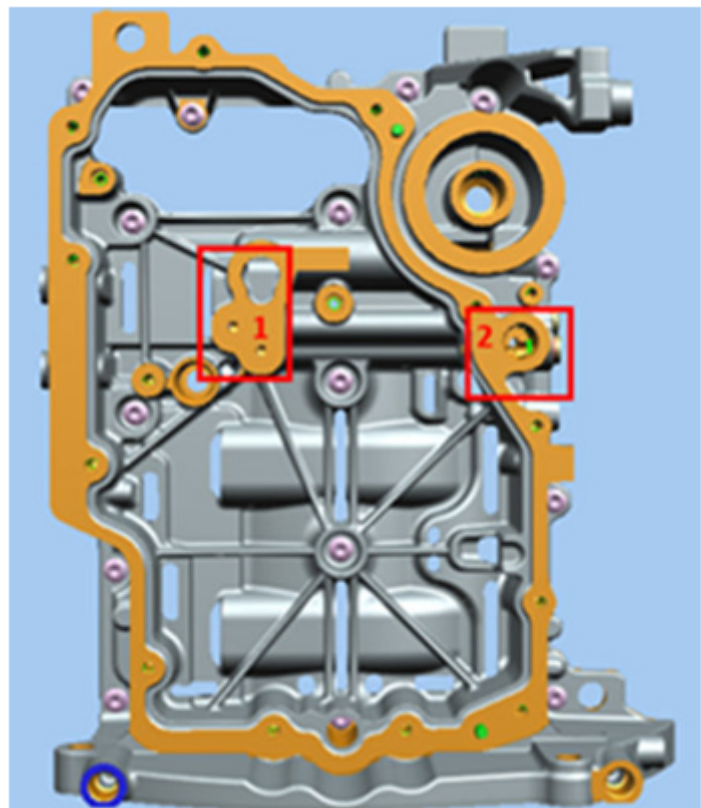
Caution: If oil pump replacement is needed, ensure the three oil pump oil holes (Area 1) and OCV mounting hole (Area 2) are free of debris BEFORE installing the oil pump and OCV. If debris is found, remove with a lint-free cloth or brush that will not scratch the surface.
