# Service Bulletin

Bulletin No.: 18-NA-115

**Subject: Cold Start Misfire and/or Rough Idle – DTC P0300 May Be Set**

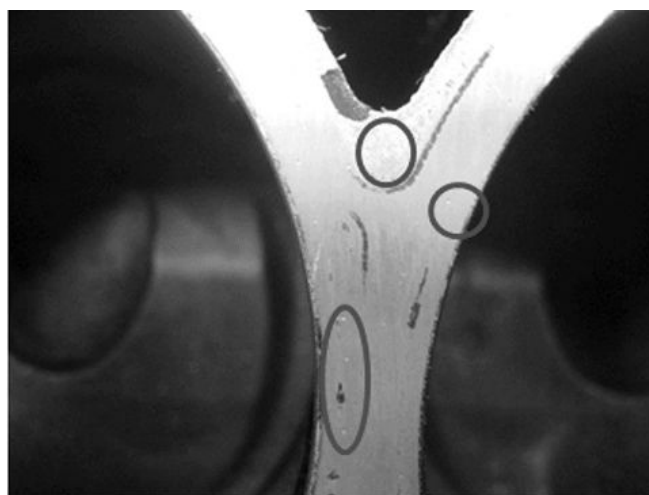
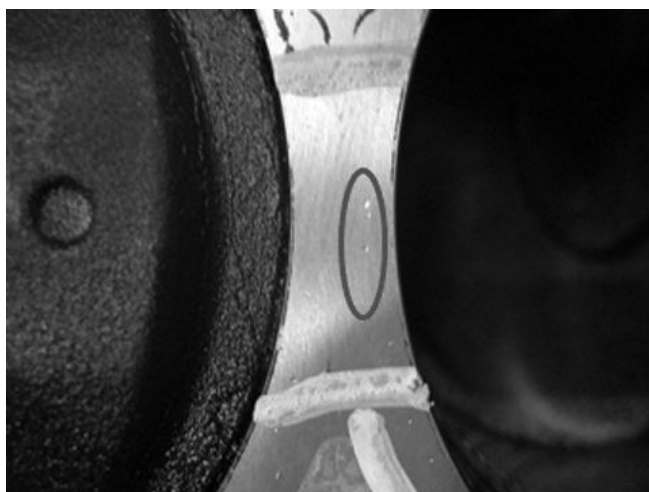
- ⇒ If the borescope inspection is inconclusive, it may be necessary to remove the cylinder head for further visual inspection.
6. With the cylinder head removed, perform a visual inspection. Reference the following pictures provided. The first two pictures represent normal examples of deck pitting and are not the cause of the misfire and/or rough idle condition.

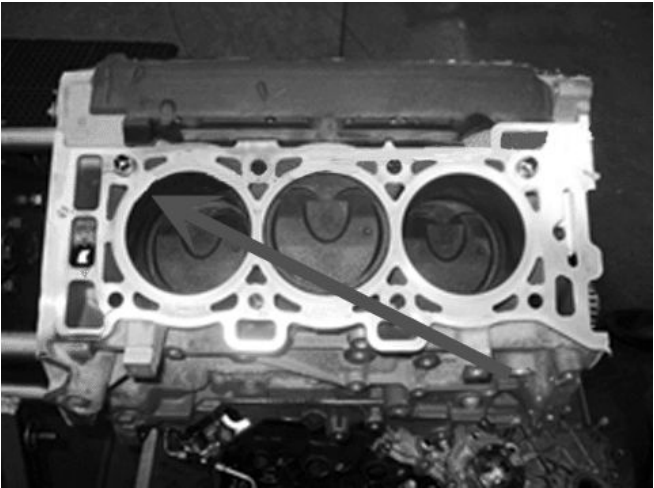
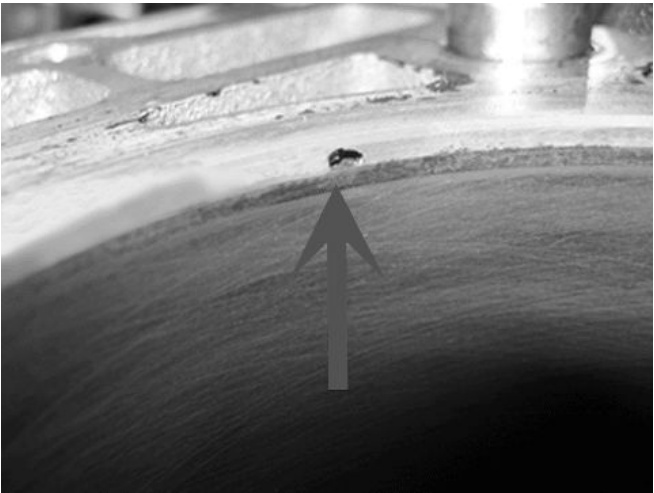
7. The two following pictures represent an example and the location of how actual engine cylinder

block porosity appears. This would be a cause of the condition.

Shown at the deck face to cylinder liner interface location is an area of engine cylinder block porosity that has caused an engine coolant leak path into the cylinder, causing medium to high misfire counts when the engine is cold.

⇒ If this condition is verified, the engine must be replaced.
