# Service Bulletin

Bulletin No.: 21-NA-271

**Subject:** Information on Malfunction Indicator Lamp (MIL) Illuminated - DTC P026A Set

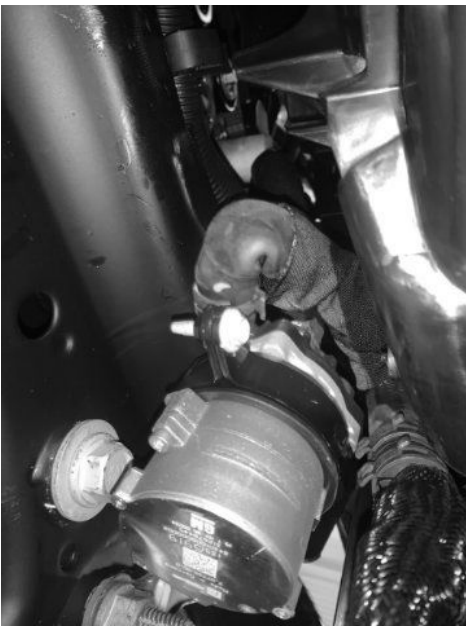
5635568

| <b>Cause</b> | This may be due to a kinked hose at or near the low temperature auxiliary coolant pump. |

If this condition is encountered, loosen the hose clamp and rotate the hose to allow for proper coolant flow.
