**TECHNICAL SERVICE BULLETIN****3.5L PowerBoost - Lariat/XLT/XL Trim Levels - Right Side Turbocharger Concerns****24-2264**23 August  
2024**Model:**

| <b>Ford</b> | Engine: 3.5L PowerBoost |
| 2024 F-150 | Lariat/XLT/XL trim level |

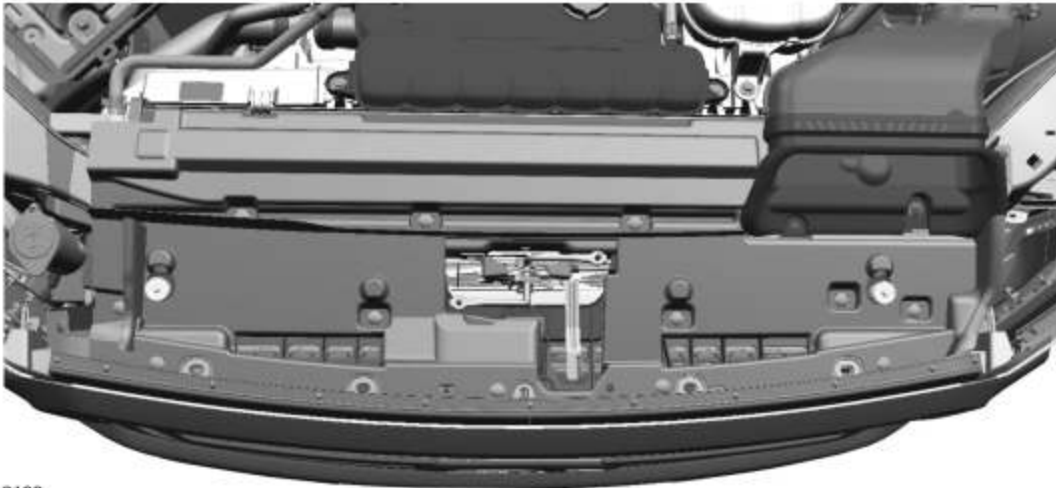
Figure 1

1. Does the upper air deflector match the one outlined in Figure 1?

(1). Yes - proceed to Step 2.

(2). No - this article does not apply. Refer to the WSM for additional diagnostics.
