## Technical Service Bulletin

| <b>CAMPAIGN</b> | <b>24-01-070G</b> |
| <b>AUGUST 2024</b> | <b>GV60 (JW1 EV)</b> |

**SUBJECT:** BMS UPDATE FOR DTC P1AA900 – CELL VOLTAGE VARIANCE  
(SERVICE CAMPAIGN T57G)

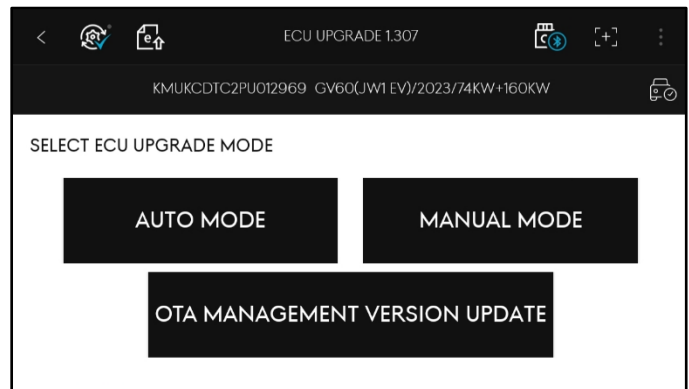
1. Perform the ECU update in **Auto Mode**.

Use the **ID Check** to verify the ROM ID before updating the software.

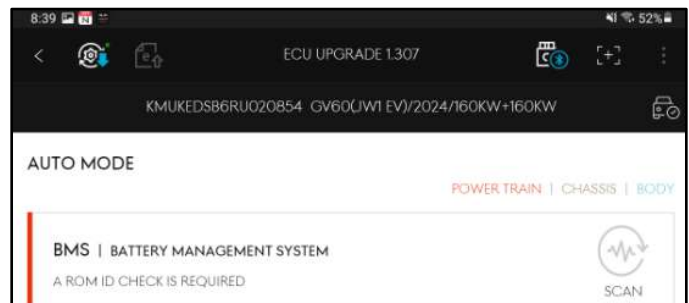
2. Select the **BMS** system to scan the vehicle's current ROM ID.

Check the current ROM ID version and compare it to the ROM ID Information table before attempting to perform the software update.

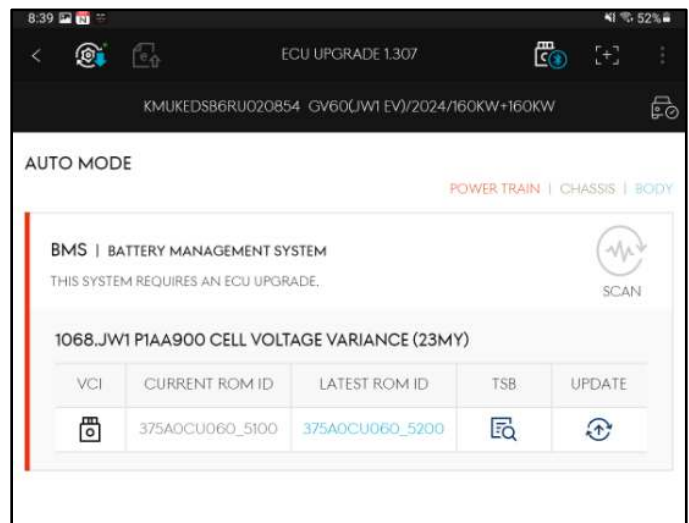
If the update fails, please remove the power connector or the battery (–) connector from the indoor fuse box for at least 5 seconds and reassemble it to retry the update.

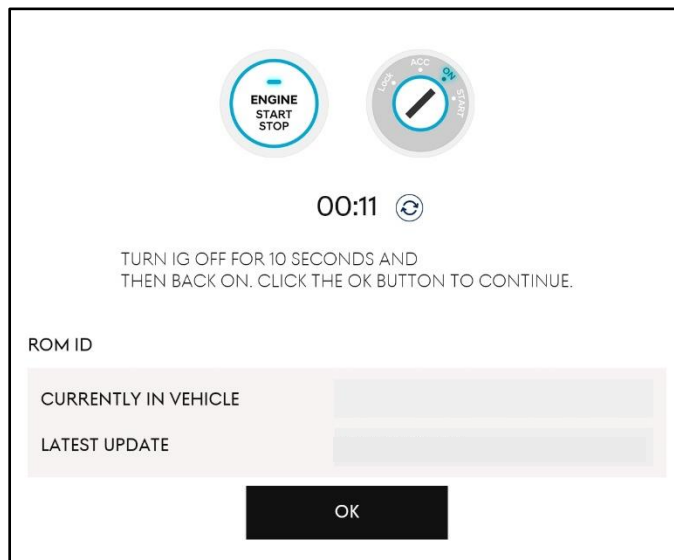
3. After the ECU update process shows 100% complete, follow the prompts on the screen to cycle the ignition **OFF** for at least **10 seconds** to reset the control unit (certain models may take up to **30 seconds**).

Use the **Refresh** button to reset the timer.

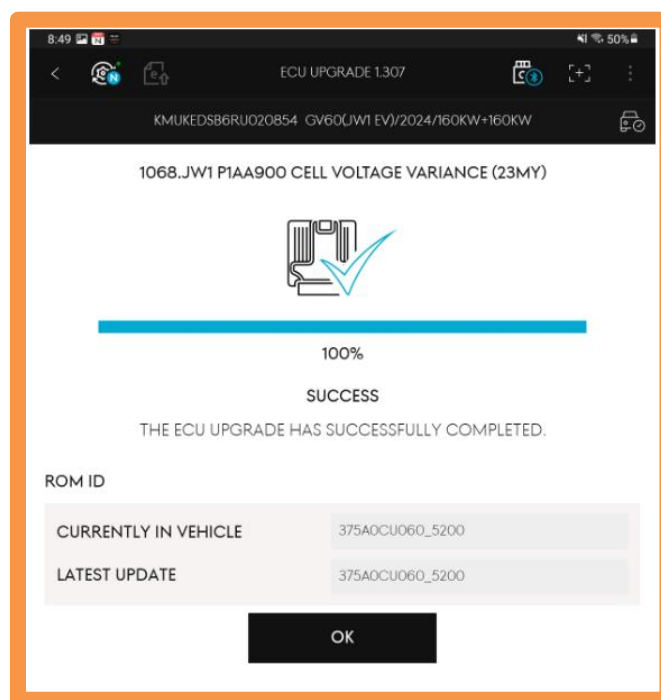
Take a screenshot of the ECU update complete screen using your tablet and upload to STUI.
