# Service Bulletin

Bulletin No.: 24-NA-125  
Date: August, 2024

**Subject:** Diagnostic Tip: Antilock Brake System (ABS) Lamp Illuminated, Diagnostic Trouble Code — DTC's — C0513, C0514, C0515, C0516

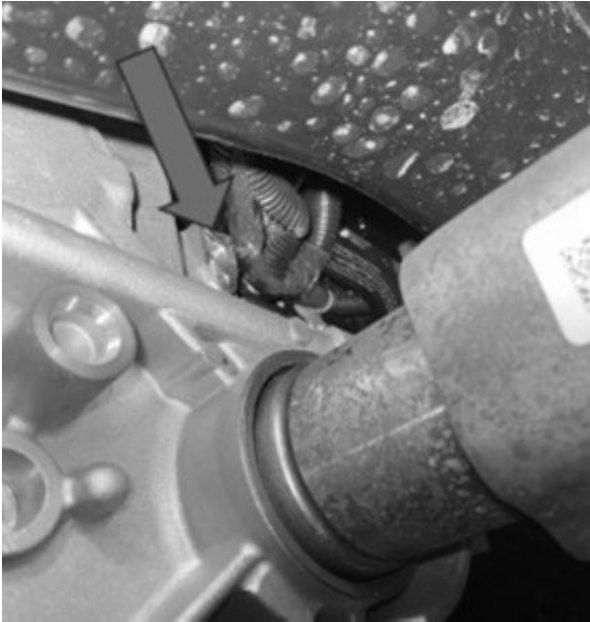
6580315

| Condition | Some customers may comment on an ABS light illuminated followed with a "Service Stability " message. |

| Correction | Inspect the location show above the right rear axle and repair wiring and re-route harness as needed. |

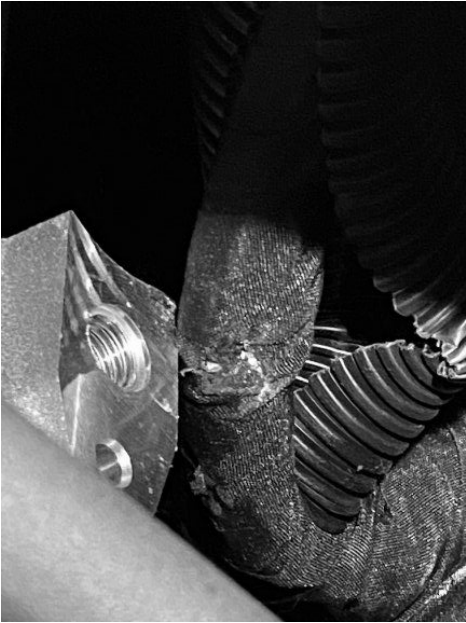
| | <div></div> <div>6580193</div> <div>The cause of the condition may be the ABS wiring harness making contact with the top edge of the rear drive unit (DU) above the right rear axle.</div> |
