| Subject:<br><br>EXTERIOR LIGHT WARNING WITH DTC B10A3:86 | Bulletin No.: 09-039/24 |
| | Last Issued : 08/09/2024 |

APPLICABLE MODEL(S)/VINS

2024 CX-90 (All)  
2025 CX-90 with VINS lower than JM3KJ\*\*\*\*\*116689 (produced before July 31, 2024)  
2025 CX-70 with VINS lower than JM3KK\*\*\*\*\*189865 (produced before July 2, 2024)

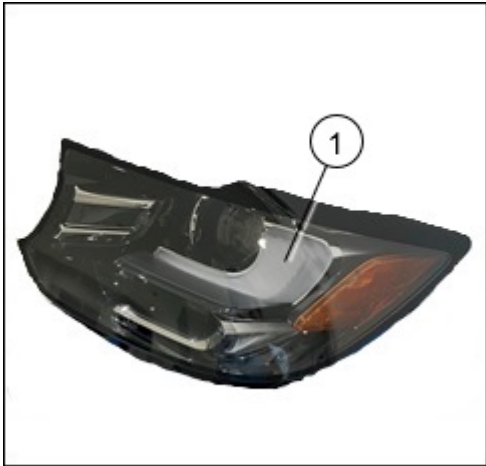
Some vehicles equipped with the Adaptive Front lighting System (AFS) may exhibit the exterior light warning light/exterior light warning indication on while driving or when the ignition is turned on and DTC B10A3:86 (Error signal received from swivel actuator (LH)) stored in memory.

Exterior light warning light

Combination light with AFS  
(1): Parking light/daytime running light (DRL)
