# TECHNICAL SERVICE BULLETIN

| Classification:<br>AN22-007B | Reference:<br>ITB22-017B | Date:<br>August 15, 2024 |

## DTC B2E01-96 (INTERNAL BATTERY) STORED AS CURRENT IN IVC

**APPLIED VEHICLES:** 2020-2024 Q50 (V37)  
2020-2022 Q60 (CV37)  
2020-2024 QX50 (J55)  
2022-2024 QX55 (FJ55)  
2022-2024 QX60 (L51)  
2020-2024 QX80 (Z62)

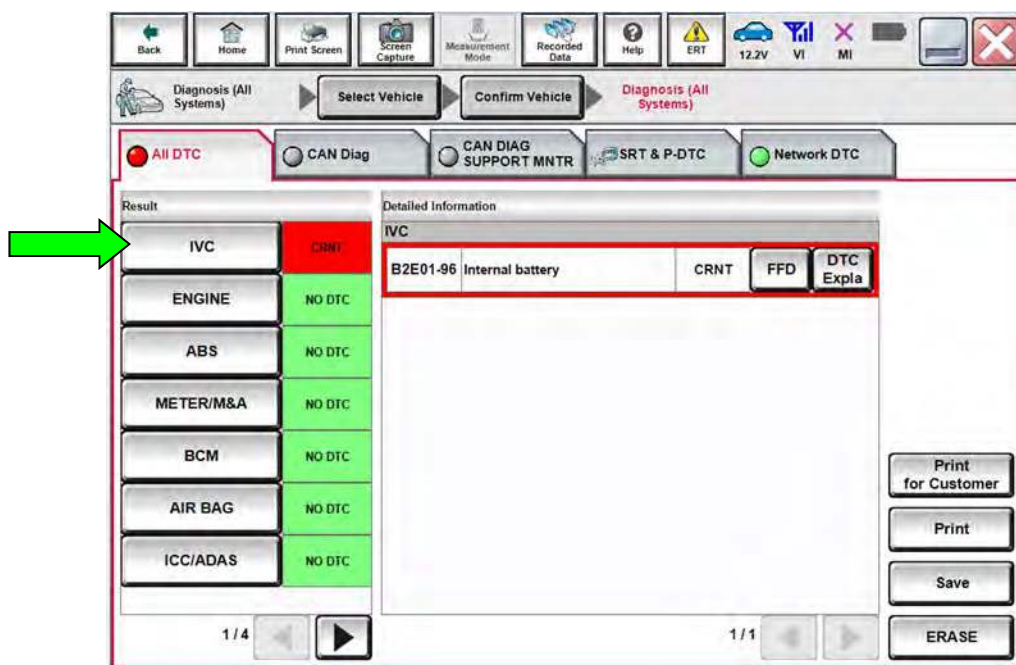
Figure 3

11. Confirm that DTC B2E01-96 for “Internal battery” is “CRNT” in the **IVC**.

- If only DTC B2E01-96 is present, select **IVC** (Figure 3) and then proceed to step 12.
- If additional DTCs, other than B2E01-96, are present in the **IVC**, refer to the ESM for further diagnostic information and repair first, and then proceed to step 12.
