# TECHNICAL SERVICE BULLETIN

| AN22-006B | NTB22-027B | August 15, 2024 |

## DTC B2E01-96 (INTERNAL BATTERY) STORED AS CURRENT IN IVC

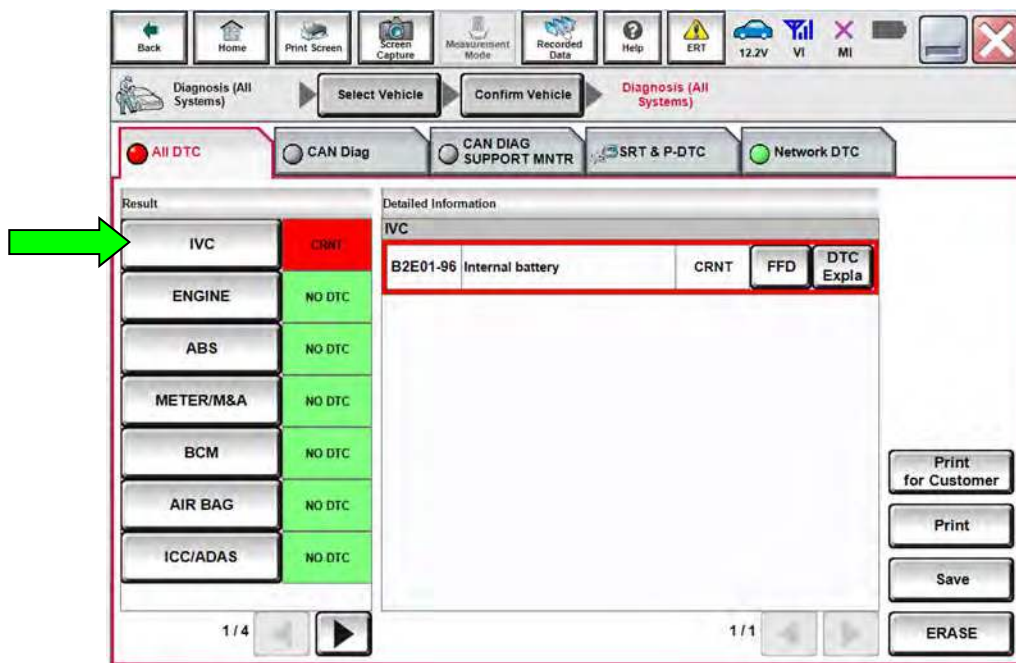
Figure 3

11. Confirm that DTC B2E01-96 for “Internal battery” is “CRNT” in the **IVC**.

- If only DTC B2E01-96 is present, select **IVC** (Figure 3) and then proceed to step 12.
- If additional DTCs, other than B2E01-96, are present in the **IVC**, refer to the ESM for further diagnostic information and repair first, and then proceed to step 12.
