# Service Bulletin

Bulletin No.: 22-NA-128  
Date: August, 2024

**Subject:** Malfunction Indicator Lamp (MIL) Illuminated - DTC P0172, P026D, P2459, and/or P2A00 Set

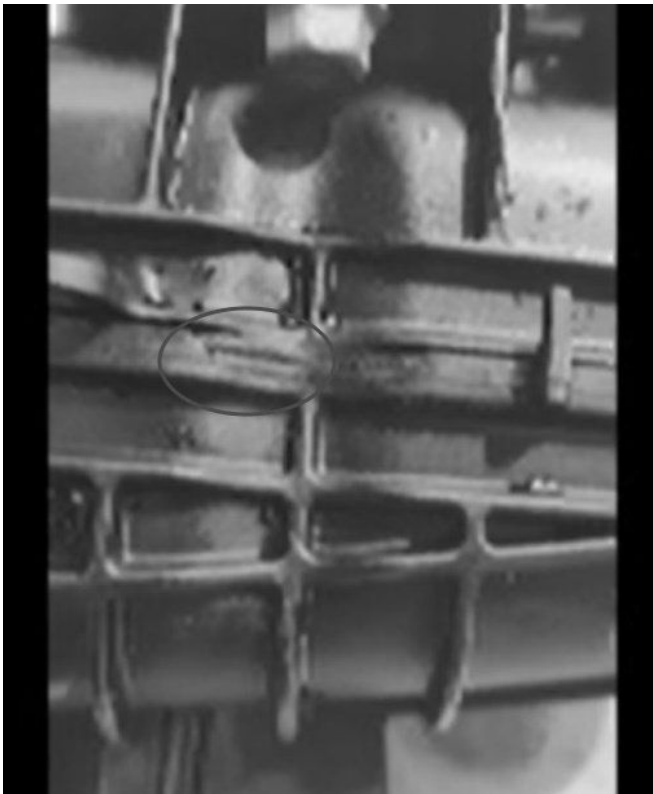
| <b>Cause</b> | <div data-bbox="529 241 1184 1032"></div> <div data-bbox="529 1131 1497 1160">This condition may be caused by a leak at the intake manifold.<div>6102369</div></div> |

| <b>Correction</b> | <div data-bbox="529 1176 1497 1263">The technician can find this leak by testing using the <i>Component/System Leak Test in SI</i> or bulletin PIP5684.<br/>If a leak is found in the intake manifold, replace the intake manifold.</div> |
