# Technical Service Bulletin

## 91 ConBox Low: SOS Malfunction - DTC U142100 stored in the gateway

91 24 48 2070942/4 August 30, 2024. Supersedes Technical Service Bulletin Group 91 number 24-05 dated April 26, 2024 for reasons listed below.

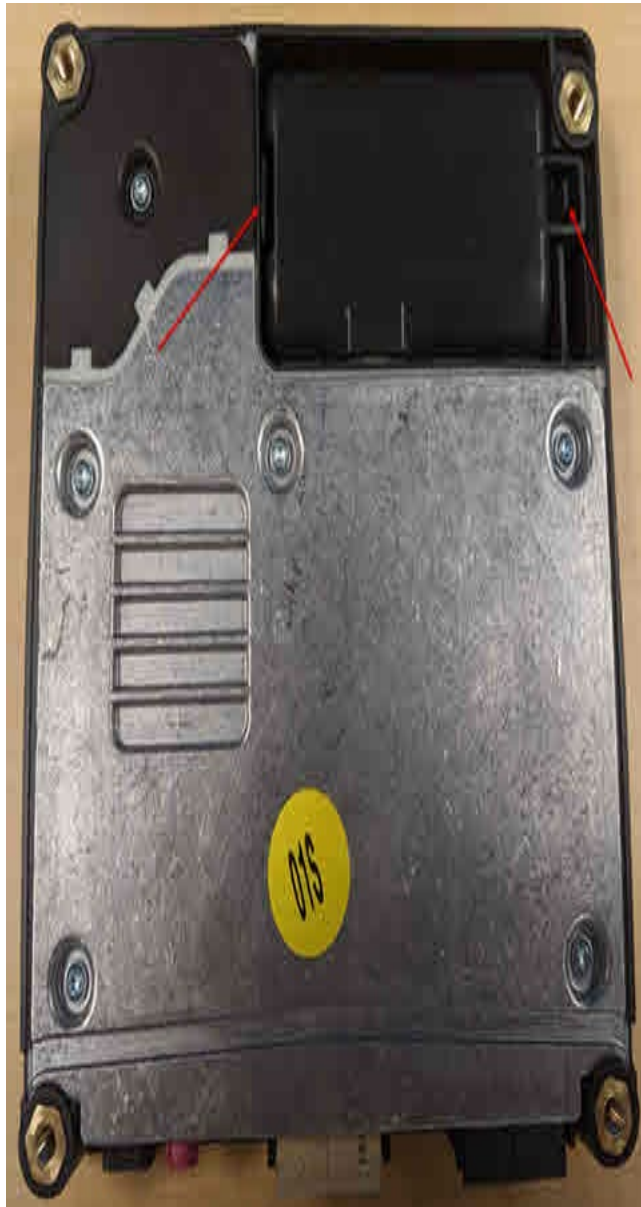
*Figure 2. Backup battery compartment location.*

2. Open the battery compartment of the control module for the emergency call module and communication unit, -J949- (address word 0075), and disconnect the backup battery (Figures 2 - 3).

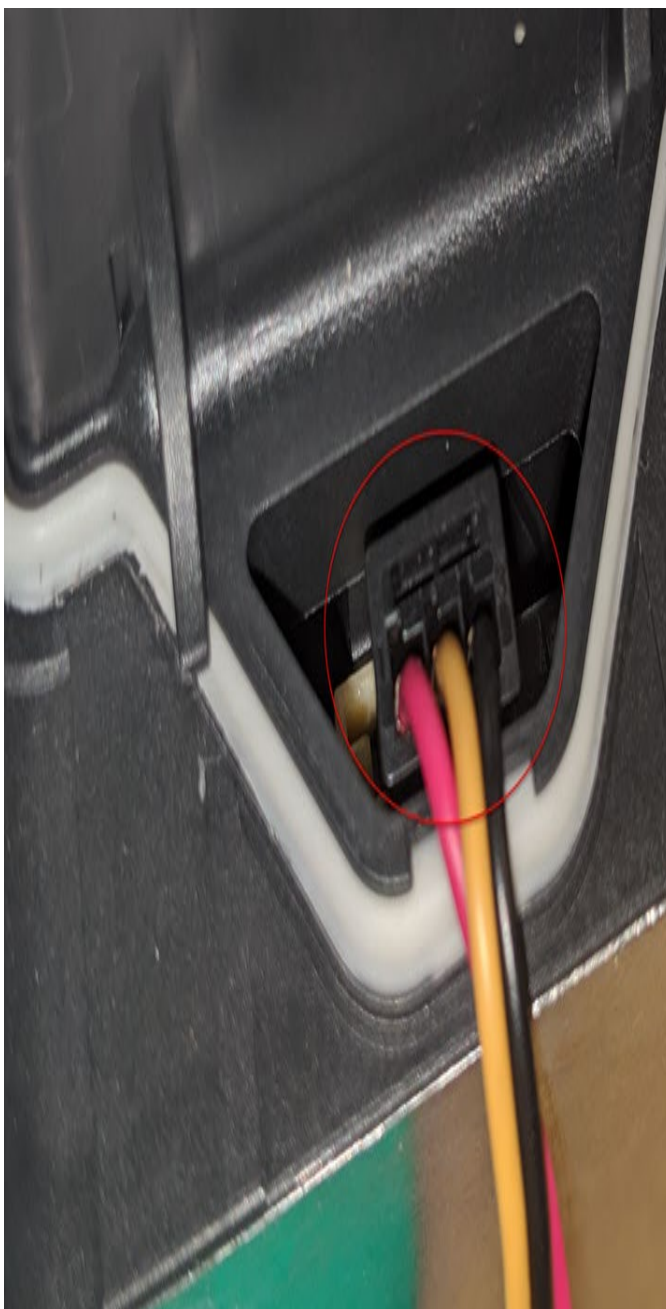
*Figure 3. Backup battery connector (no release mechanism).*

3. Wait approximately one minute, then reinstall the backup battery back into the control module for the emergency call module and communication unit, -J949- (address word 0075).
