# Service Bulletin

Bulletin No.: 24-NA-027  
Date: August, 2024

**Subject: DTC U3000 Setting in Automated Map Module (HDLM) - SuperCruise Unavailable**

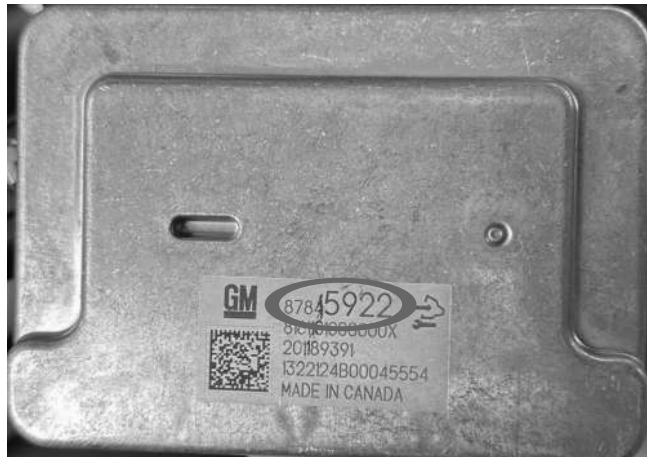
6553204  
If one of these Map module part numbers listed in Parts Information is not installed in the vehicle, and the map module is setting the U3000 DTC with SuperCruise being unavailable, do not replace the module until additional diagnostics through SI are completed.
