## Technical Service Bulletin (TSB)

### Exhaust Gas Temperature (EGT) Sensor Replacement

| REFERENCE: | TSB: 25-004-24<br>GROUP: 25 - Emission Control | Date: | September 25, 2024 | REVISION: | — |
| VEHICLES AFFECTED: | 2023 (WL) Jeep Grand Cherokee / Grand Cherokee L<br>This bulletin applies to vehicles built on or after June 01, 2023 (MDH 0601XX) and on or before December 31, 2023 (MDH 1231XX) equipped with a 2.0L I4 DOHC DI Turbo Engine w/ ESS (Sales Code ECI) or a 2.0L I4 DOHC DI Turbo PHEV Engine (Sales Code ECX). | | | MARKET APPLICABILITY:<br><div><input type="checkbox"/> NA<input type="checkbox"/> MEA</div> <div><input type="checkbox"/> SA<input checked="" type="checkbox"/> IAP</div> <div><input type="checkbox"/> EE<input type="checkbox"/> CH</div> | |

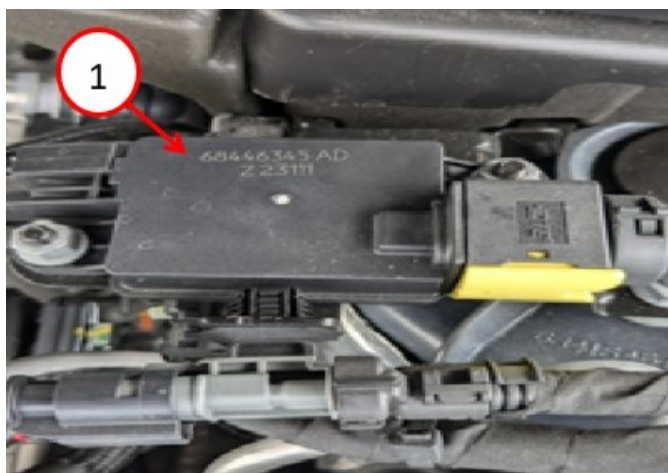
**Fig. 1**  
EGT Sensor Location

1. Is the vehicle on the RSU VIN list?
  - YES>>> Proceed to [Step 2](#).
  - NO>>> This bulletin does not apply.
2. Locate the EGT sensor [Fig. 1](#).

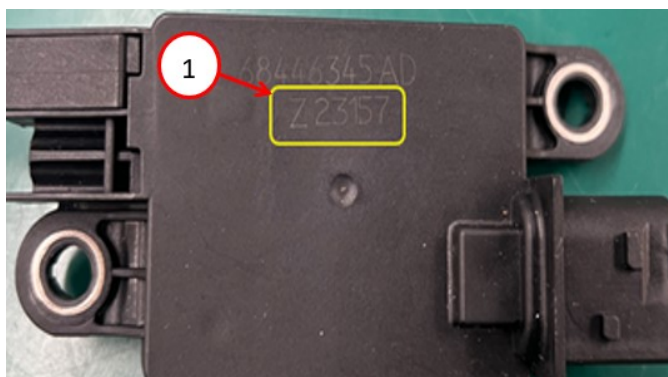
**Fig. 2**  
Date Code Location

3. Locate the date code on the EGT sensor [Fig. 2](#).

1 - Date Code Location

4. Is the date code at or between Z23109 and Z23233?
- YES>>> Proceed to [Step 5](#).
  - NO>>> This bulletin has been completed. Use Inspect LOP (25-06-07-90) to close the active RSU.
5. Replace the EGT sensor. Refer to the detailed service procedures available in DealerCONNECT/Service Library under: Service Info> 09 - Engine, 2.0L / Engine Sensors / Removal and Installation / EGT Sensor.

**NOTE: Confirm that new part date code is not between Z23109 and Z23233 before installing.**
