## Technical product information

| <b>Topic</b> | Engine cooling system over cooling - One or a combination of DTC's may be evident P218100 - P1BB400 |
| <b>Brand</b> | Bentley |
| <b>Transaction No.</b> | 2075140/1 |

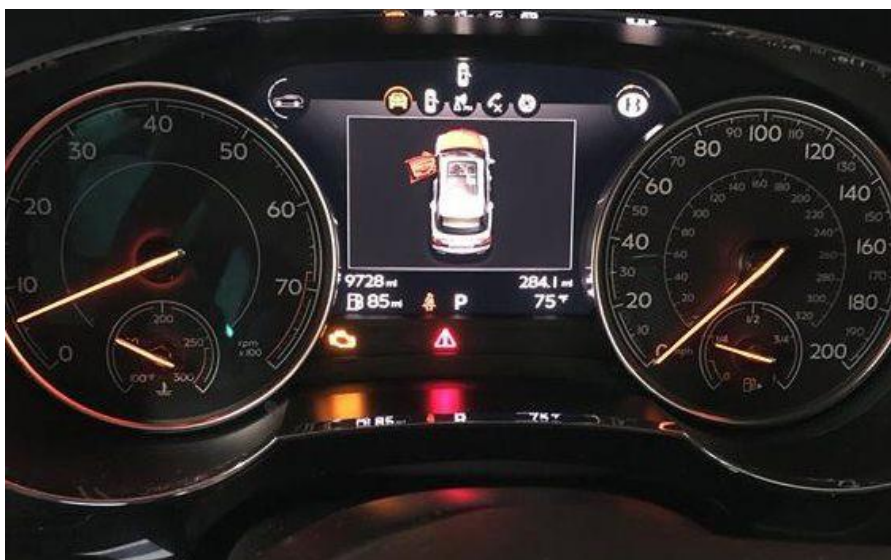
Figure 1

- DTC P218100 - Cooling System Performance and / or DTC P1BB400 Cylinder head temperature too low is stored in the Engine Control Module (ECM)
- Emission Control Lamp illuminated on the Driver Instrument Panel (Figure 1)

- The vehicle "warm up" time is longer when compared to comparison vehicles of the same specification (model / engine)

It is possible for the engine coolant thermostat to corrode over time, this corrosion is due to an adverse reaction of the thermostat material with the engine coolant

The corrosion and subsequent build-up of debris prevents the correct operation of the thermostat when closing, resulting in over cooling. The ECM triggers a DTC when the target engine temperature is outside of the specified parameter
