Warning Message “Ignition lock faulty - service required” in the Instrument Cluster / Fault Memory Entry “B143C29” in the Rear-End Electronics Control Unit (SY 47/ 24)

Model Line: 911 (992)

Concerns: Ignition starter switch

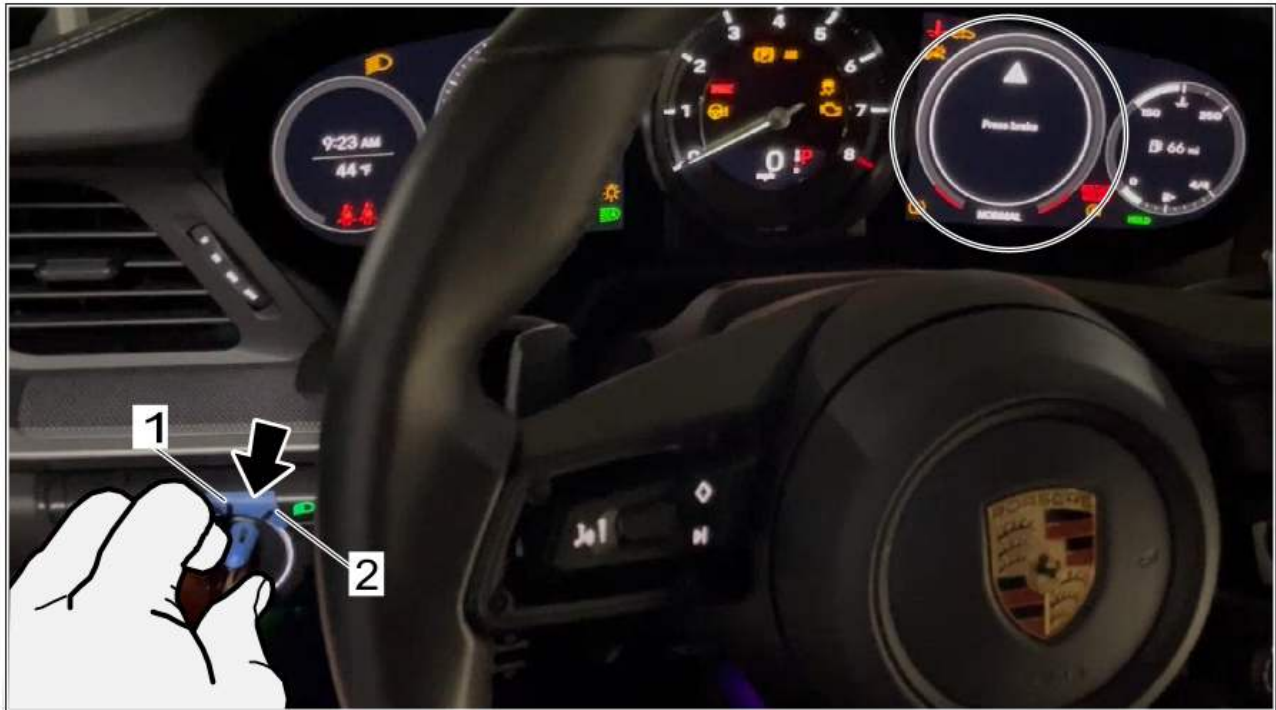
Cause: When the ignition starter switch is actuated, the engine is started through the system from the moment when the ignition starter switch is between switch position -1 - (ignition on) and switch position -2 - (engine start) ⇒ *Ignition starter switch position - Arrow-*.  
If the ignition starter switch for the engine start is not fully turned to the switch position “Start engine” ⇒ *Ignition starter switch position -2-* but is released immediately after engine start instead, thus returning to the switch position “Ignition on” ⇒ *Ignition starter switch position -1 -*, the fifth consecutive incomplete start will result in the symptom described above.

- 1 – Switch position “Ignition on”
- 2 – Switch position “Start engine”

Arrow – Engine start begins

Circle – Engine start release by “pushing brake” at ignition starter switch position ⇒ *Ignition starter switch position*  
 -Arrow-

- Remedial Action: 1 Inform the customer to turn the ignition starter switch to the "Start engine" ⇒ *Ignition starter switch position -2-* switch position each time in order to start the engine so that the system will work as intended.
- 2 Re-code control unit for rear-end electronics (BCM2).
- 3 Delete fault memory entry "B143C29 - Ignition starter switch, signal implausible (010066)" in the rear-end electronics control unit.
