**Technical Service Bulletin (TSB)**  
**Diesel Exhaust Fluid (DEF) Fluid Freezing**

| REFERENCE: | TSB: 25-007-24<br>GROUP: 25 - Emissions Control | Date: | October 1, 2024 | REVISION: | 14-005-24 |
| CAUSE: | DEF fluid freezing | | | | |

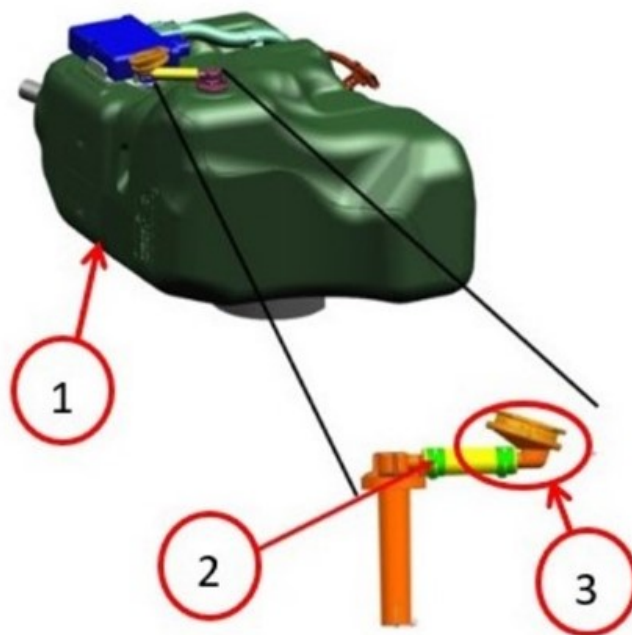
**Fig. 1**  
DEF Tank Assembly

1 - DEF Tank  
2 - Hose Clamp  
3 - GVV

1. Loosen the hose clamp on the Grade Vent Valve (GVV) hose and replace the GVV from the DEF tank [Fig. 1](#).
