| REFERENCE: | TSB: 25-006-24<br>GROUP: 25 - Emissions Control | Date: | October 1, 2024 | REVISION: | 14-008-24 |
| VEHICLES AFFECTED: | 2019 - 2022 (DJ) RAM 2500 Pickup<br>2019 - 2022 (D2) RAM 3500 Pickup<br>2019 - 2022 (DD) RAM 3500 Cab Chassis<br>2019 - 2022 (DP) RAM 4500/5500 Cab Chassis<br>This bulletin applies to vehicles equipped with the 6.7L I6 Cummins Turbo Diesel engine (Sales Codes ETL and ETN) or a 6.7L I6 Cummins HO Turbo Diesel engine (Sales Code ETM). | | | MARKET APPLICABILITY:<br><input checked="" type="checkbox"/> NA <input type="checkbox"/> MEA<br><input type="checkbox"/> SA <input type="checkbox"/> IAP<br><input type="checkbox"/> EE <input type="checkbox"/> CH | |
| CAUSE: | DEF fluid freezing | | | | |

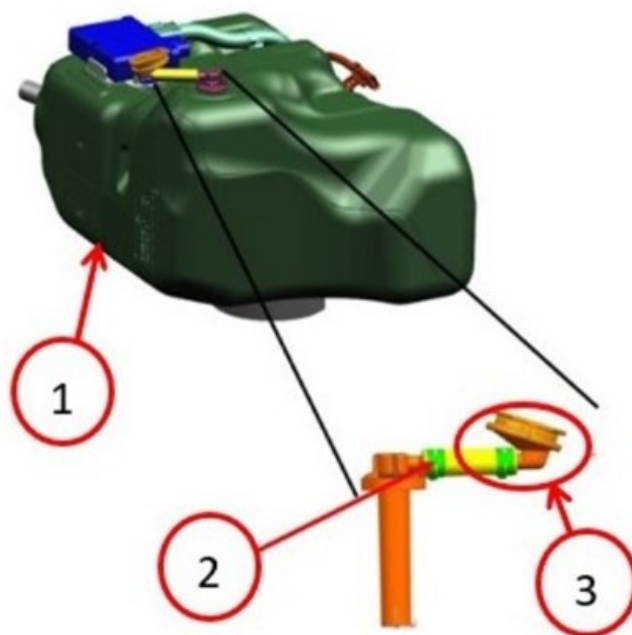
**Fig. 1**  
DEF Tank Assembly

1 - DEF Tank  
2 - Hose Clamp  
3 - GVV

2. Loosen the hose clamp on the Grade Vent Valve (GVV) hose from the DEF tank [Fig. 1](#).
