## Technical Service Bulletin (TSB)

### Rear Windshield Wipers Operate Continuously

| REFERENCE: | TSB: 08-219-24<br>GROUP: 08 - Electrical | Date: | October 4, 2024 | REVISION: | – |
| VEHICLES AFFECTED: | 2022 - 2024 (MP) Jeep Compass<br>This bulletin applies to vehicles equipped with the 2.0L I4 DOHC DI Turbo Engine w/ ESS (Sales Code EC1). | | | MARKET APPLICABILITY:<br><div><input checked="" type="checkbox"/> NA<input type="checkbox"/> MEA</div> <div><input type="checkbox"/> SA<input type="checkbox"/> IAP</div> <div><input type="checkbox"/> EE<input type="checkbox"/> CH</div> | |

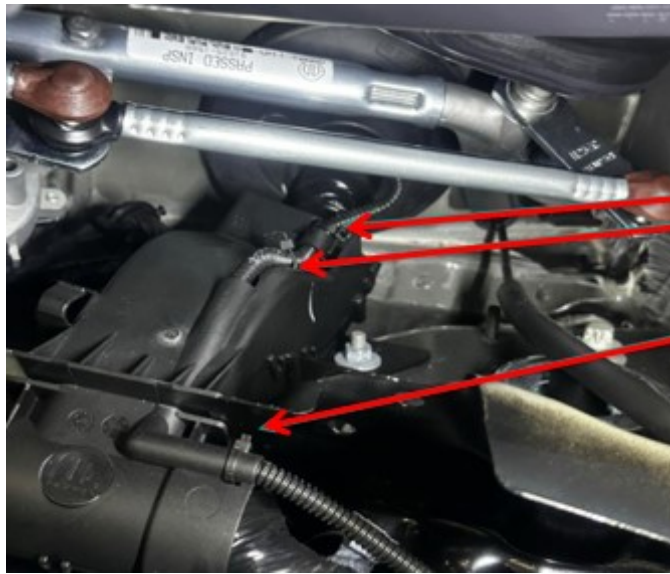
**Fig. 1**

Washer Hose Trough Tie Down Strap Locations

4. Remove and **DISCARD** the washer hose trough tie down straps [Fig. 1](#).

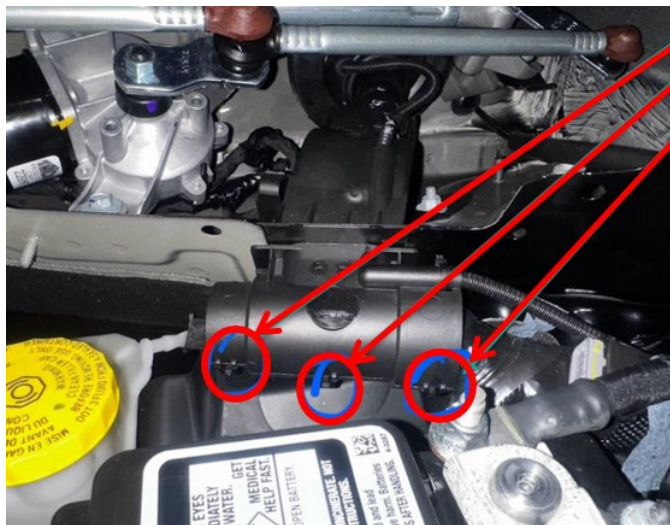
**Fig. 2**

Washer Hose Trough Clip Locations

5. Release the trough clips [Fig. 2](#).

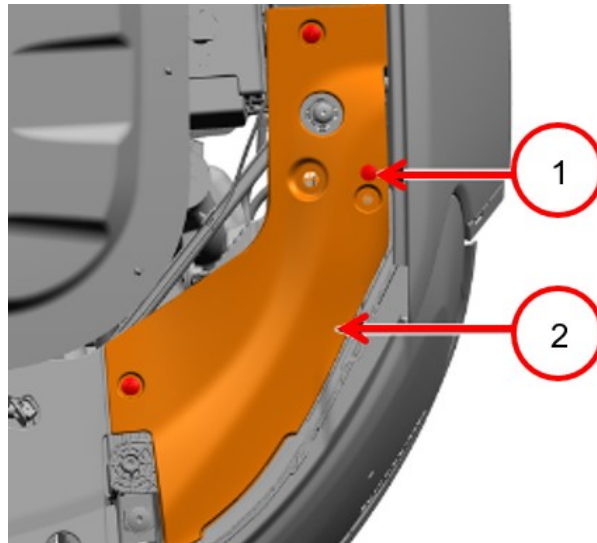
**Fig. 3**

Headlamp Close Out Panel

1 - Close Out Panel Clips  
2 - Close Out Panel

6. Remove the headlamp close out panel [Fig. 3](#).

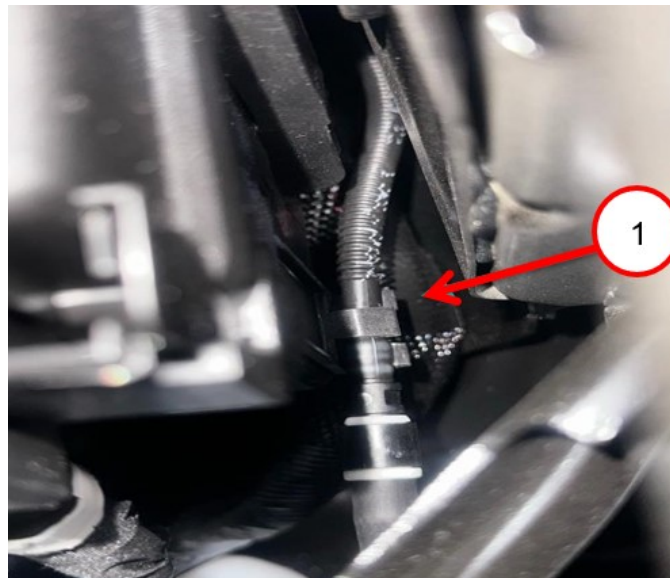
**Fig. 4**

Washer Hose Location - PDC Support

1 - Washer Hose At PDC Support Location

7. Remove the washer hose from the Power Distribution Center (PDC) support [Fig. 4](#).

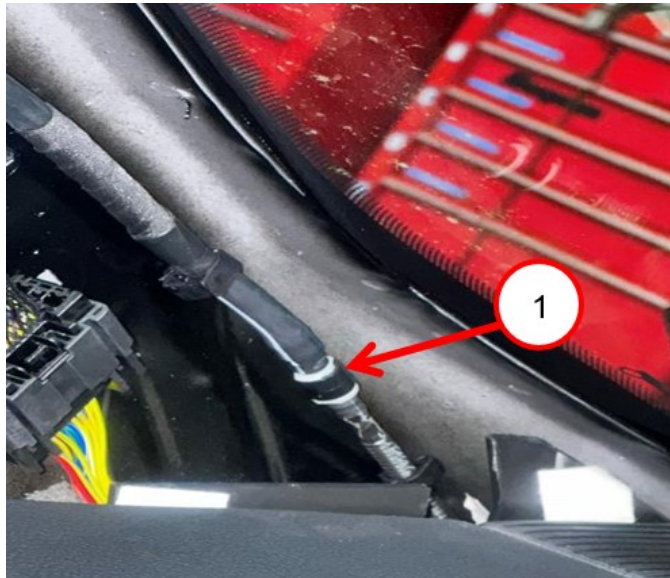
**Fig. 5**

Rear Windshield Inline Wiper Hose Connection

1 - Rear Windshield Inline Wiper Hose Coupler

11. Disconnect the washer hose from the rear windshield inline wiper hose coupler [Fig. 5](#).

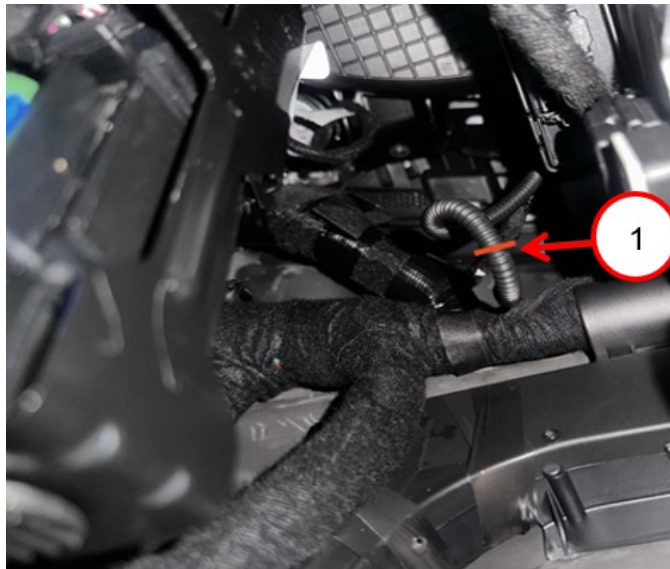
**Fig. 6**

Damaged Hose Location

1 - Cut Location For Existing Hose

12. Cut the damaged hose under the instrument panel [Fig. 6](#). **Do not remove the hose at this time.**

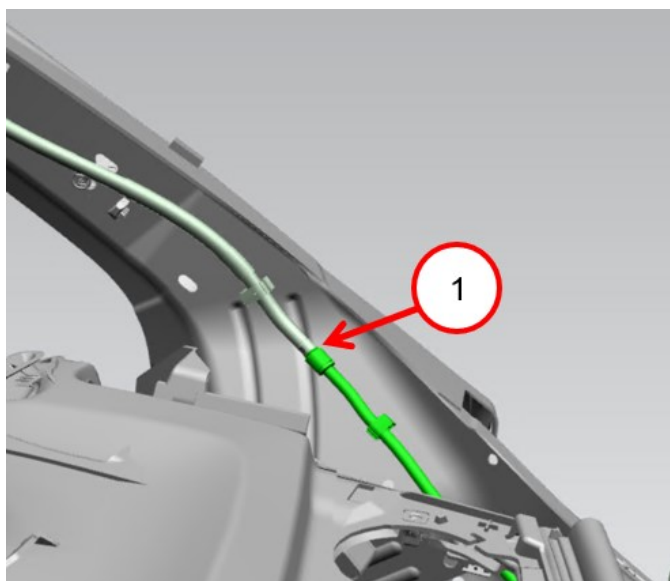
**Fig. 9**  
Rear Washer Inline Hose

1 - Rear Washer Inline Hose Coupler

15. Connect one end of the new hose to the rear windshield wiper inline hose [Fig. 9](#).

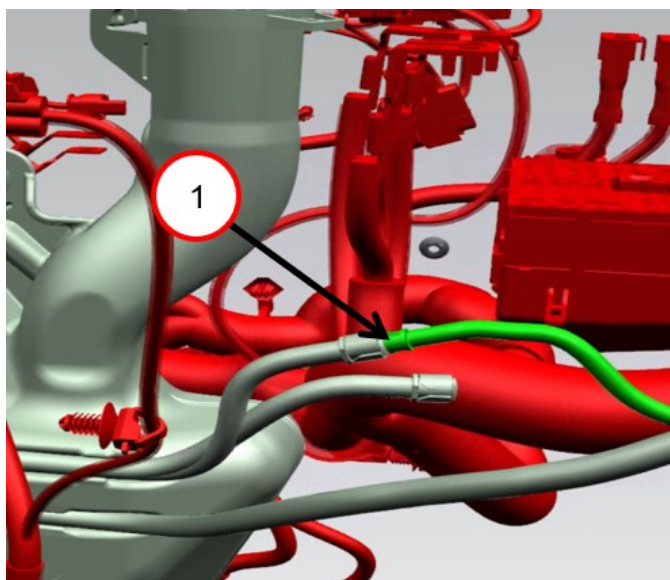
**Fig. 10**  
Windshield Washer Reservoir

1 - Windshield Washer Reservoir Coupler

16. Connect the other end of the new hose to the windshield washer reservoir [Fig. 10](#).
