# Service Bulletin

Bulletin No.: 24-NA-158

**Subject: Malfunction Indicator Lamp Illuminated with Active DTC P0102 and Possibly U060F and U1346 at the Mass Air Flow Sensor**

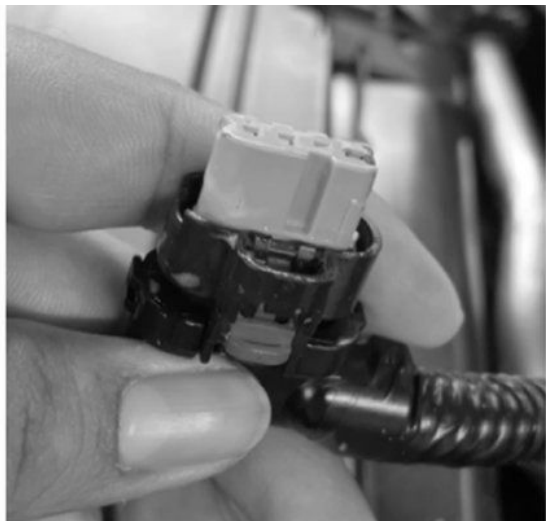
6719228

| Condition | Some customers may comment on a malfunction indicator lamp illuminated.<br>During diagnosis a technician may find an Active DTC P0102 and possibly U060F and U1346 at the Mass Air Flow Sensor. |
| Cause | The cause of the condition may be water infiltration in the MAF (Mass Air Flow) connector during assembly. |

Replace the MAF sensor and MAF sensor connector with a service connector.

Refer to *Mass Airflow Sensor Replacement* in SI.

**Note:** Be sure to reuse the MAF sensor connector dress cover when completing the repair.
